Sandy City – Old City Hall Study Update

Date: December 6, 2017
To: Todd Asay
From: CRSA – Susie Petheram, Kelly Gillman
Re: Summary of site visit, code analysis, cost considerations

Sandy City Old City Hall Study

June 2008

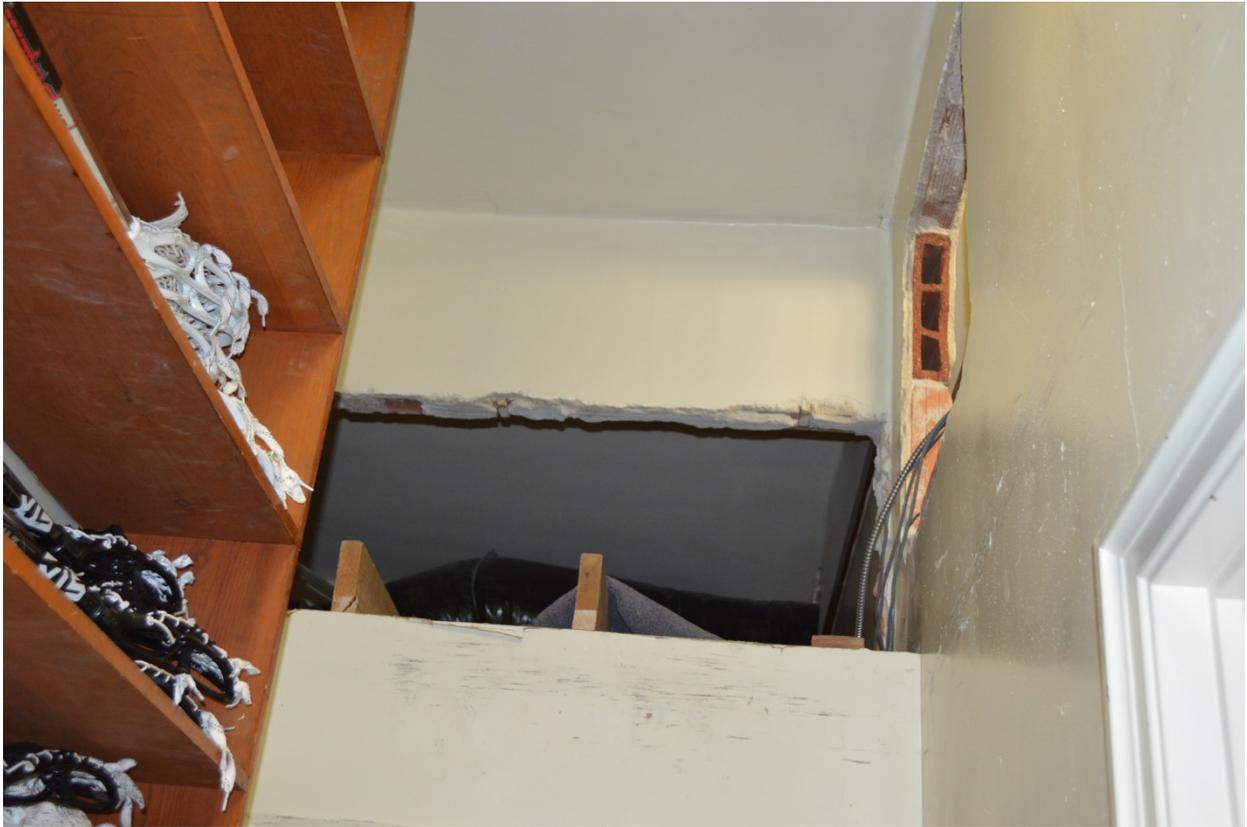
- Spaces are still used by various community groups and the conference room is also available for rental by the community. Much of the lower level space vacated by the Boys and Girls Club is being used for recreation equipment storage. *(see Image # 2)*
- The soft clay structural aspects of the building were noted as problematic by city staff. *(see Image # 3)*

Image 3: The of the soft clay tiles of the interior wall structure is visible where holes have been made to run mechanical/electrical systems.

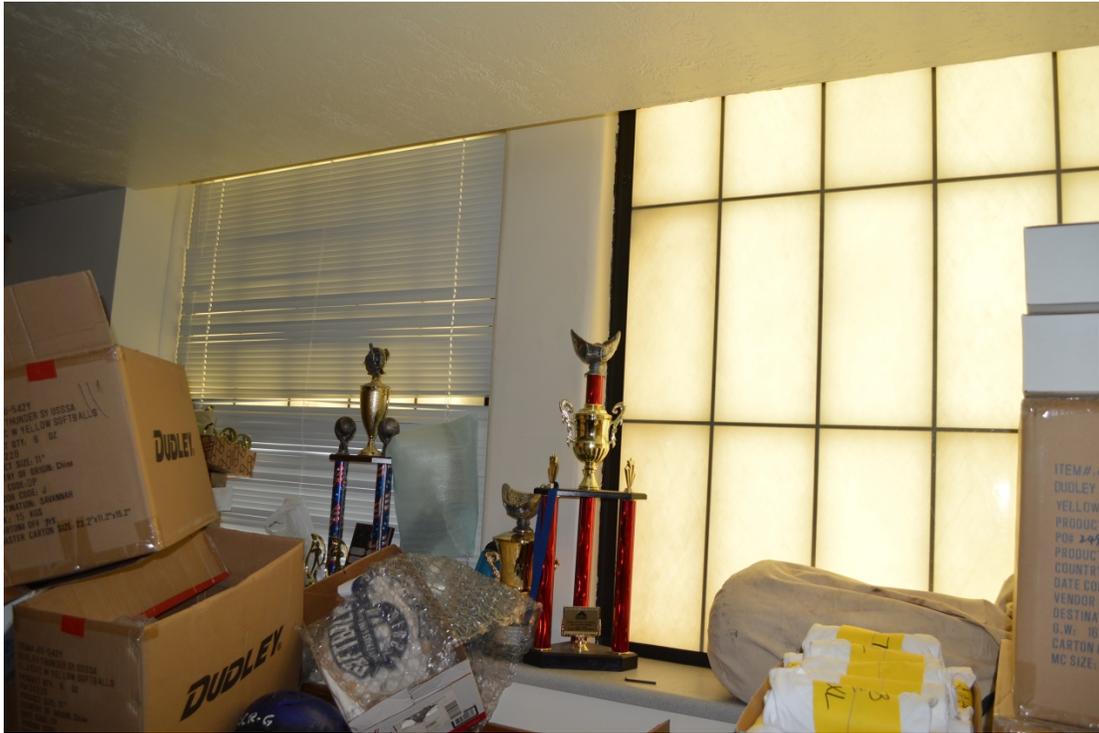
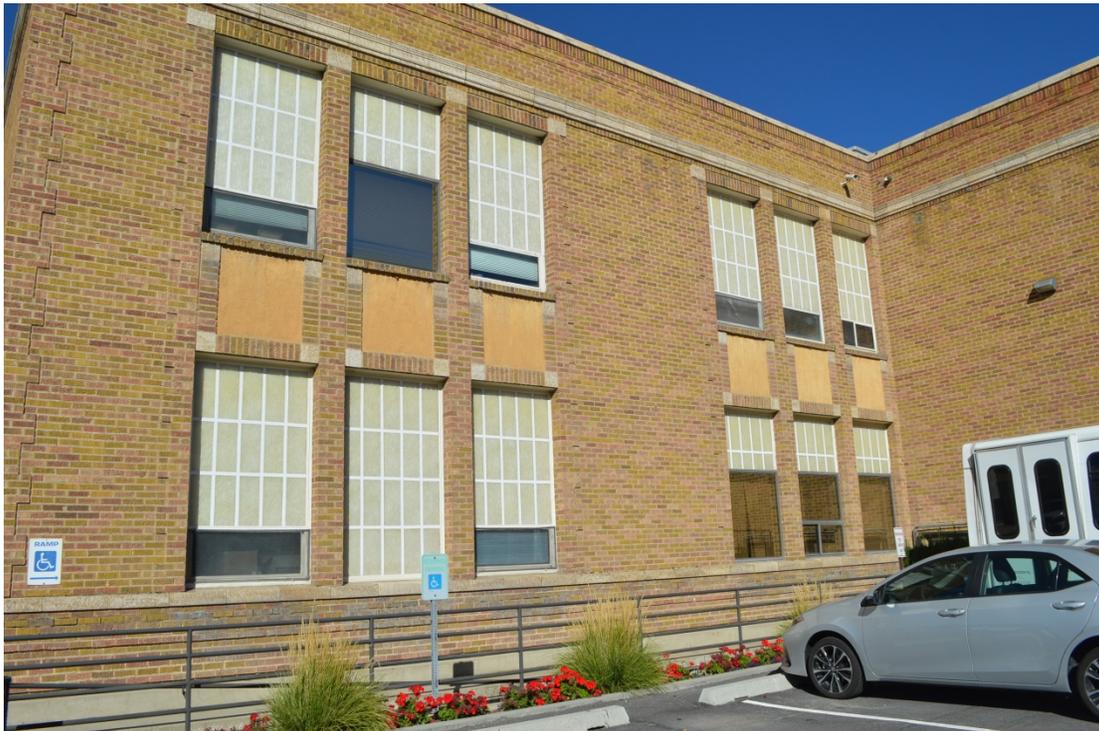
- The fiberglass window coverings, which offer insulation benefits but block the full height and beauty of the historic windows, are breaking down from exposure to sunlight. These are probably 30 to 40 years old and date to the city's occupation of the building as the city hall. On the inside, mildew is forming from leaks. *(see Image # 4 & 5)*

Images 4 & 5: The fiberglass covering on the windows is beginning to degrade, traps moisture leading to mildew, and also blocks the full beauty of the original windows.

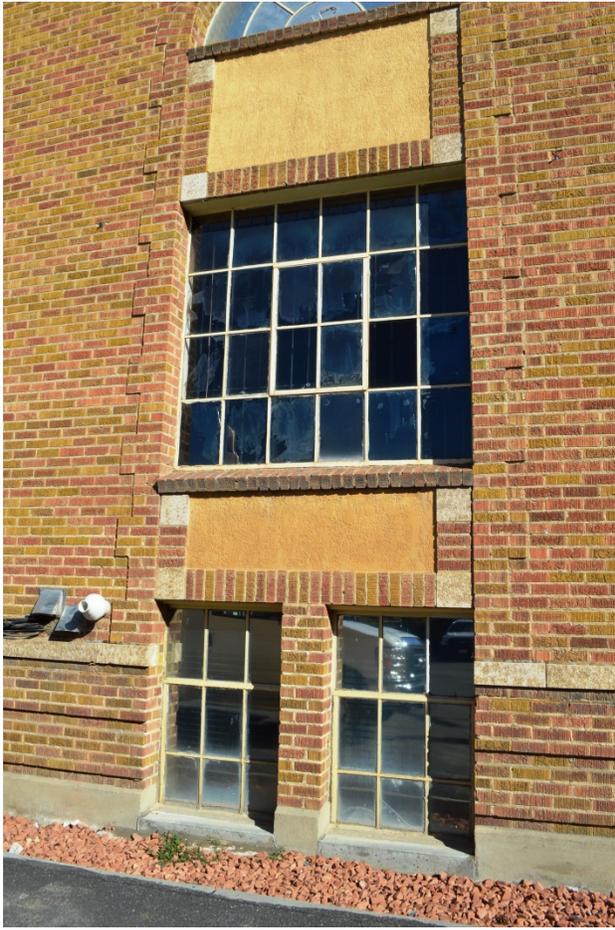
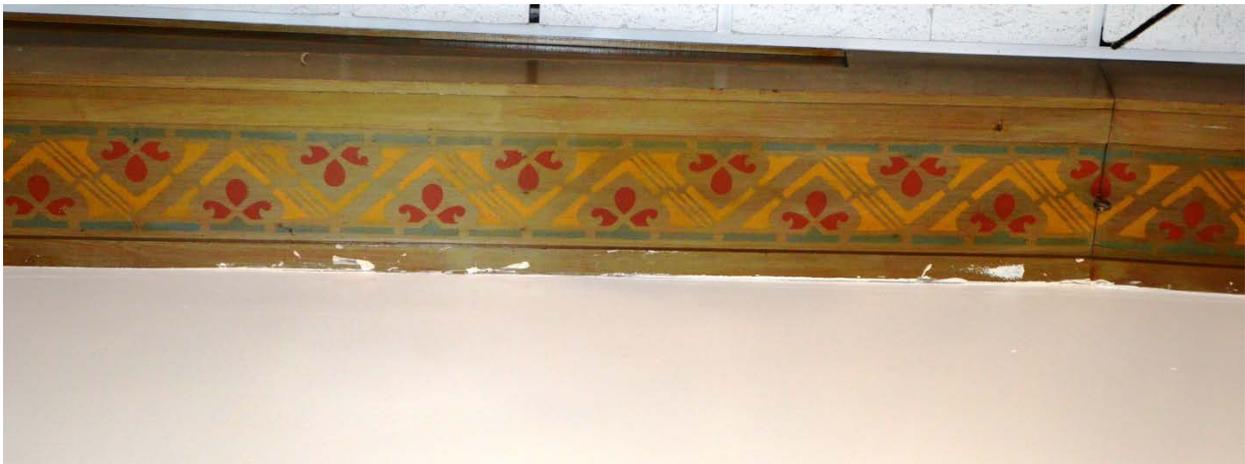
Images 6 & 7: The exterior color scheme, including the yellow of the stucco accents is likely original, yet faded. The exterior color scheme was likely consistent with the original colors used on the interior, which are still visible in the beams of the gymnasium

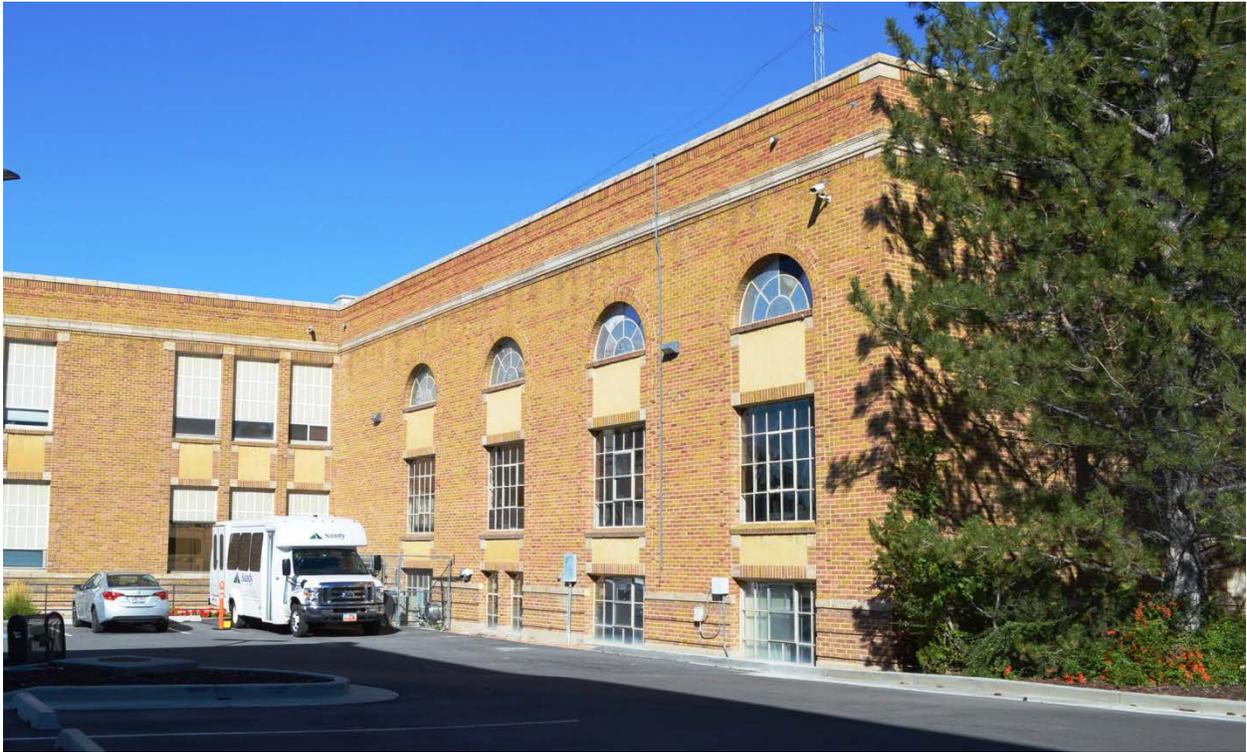
- When the new lower level conference room was remodeled, there was significant evidence of water damage/staining on the carpet underneath the south windows and cracking on the walls. The landscaping was removed directly outside these south windows and replaced with rocks. A concrete curb was added directly adjacent to the windows to divert water away from the foundation. However, this has now created the situation where small amounts of moisture lead and are trapped next to the window below the curb level (the windows on the lower level extend below the grade of the parking lot). The glazing material of the window is being impacted by this trapped moisture, leading to cracks and deterioration. *(see Image # 8)*

Images 8: A new concrete curb was installed on the south side of the gymnasium wing to divert water; however, water is still being trapped against the window leading to degradation of the glazing.

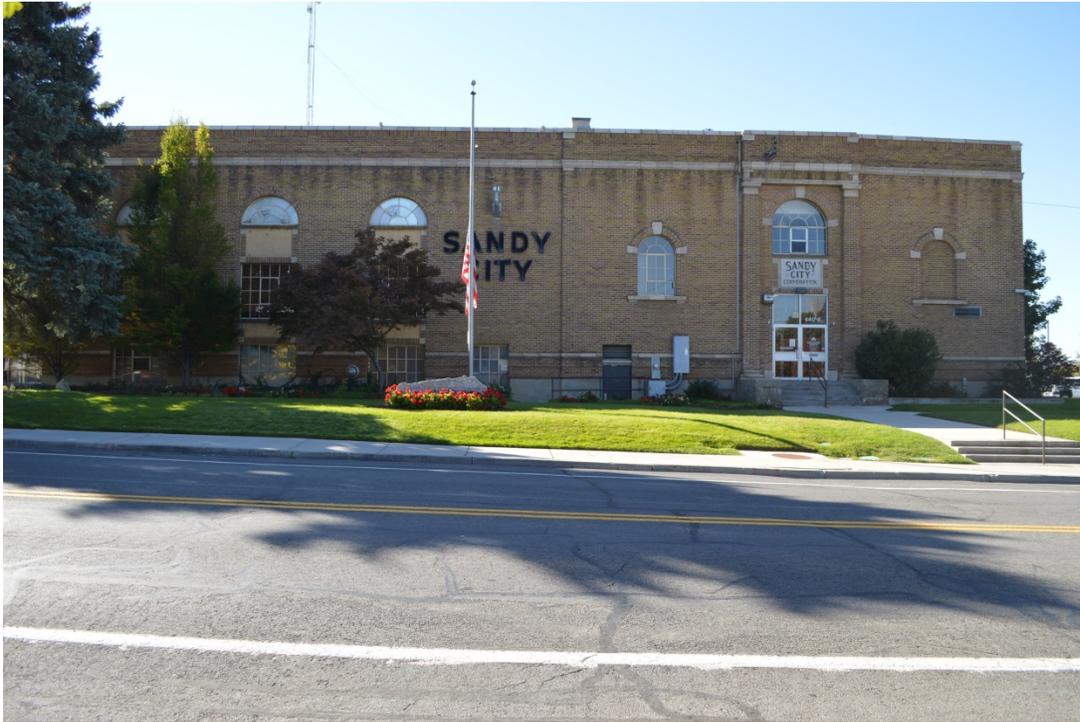
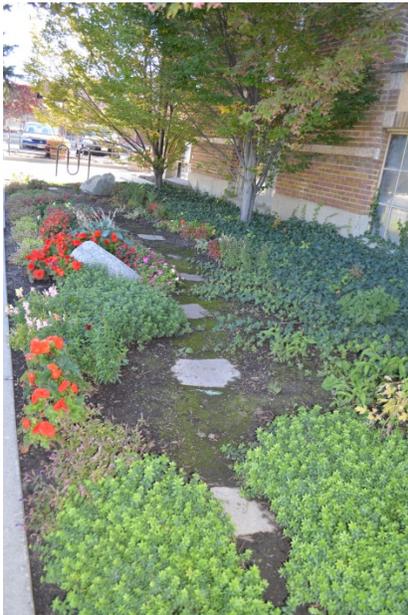
- The chain link fence on the north side has been removed and the landscaping updated to improve the appearance of the site. The ground on the north side of the building was noted to be very wet/moist with moss in the landscape. This may lead to moisture infiltration problems with proximity to the foundation if the ground is not sloped away from the foundation. *(see Image #9 & 10)*

Images 9 & 10: The front landscape has been updated. The planted area adjacent to the building was noted to be very moist, which may be of concern in relation to the foundation of the building.

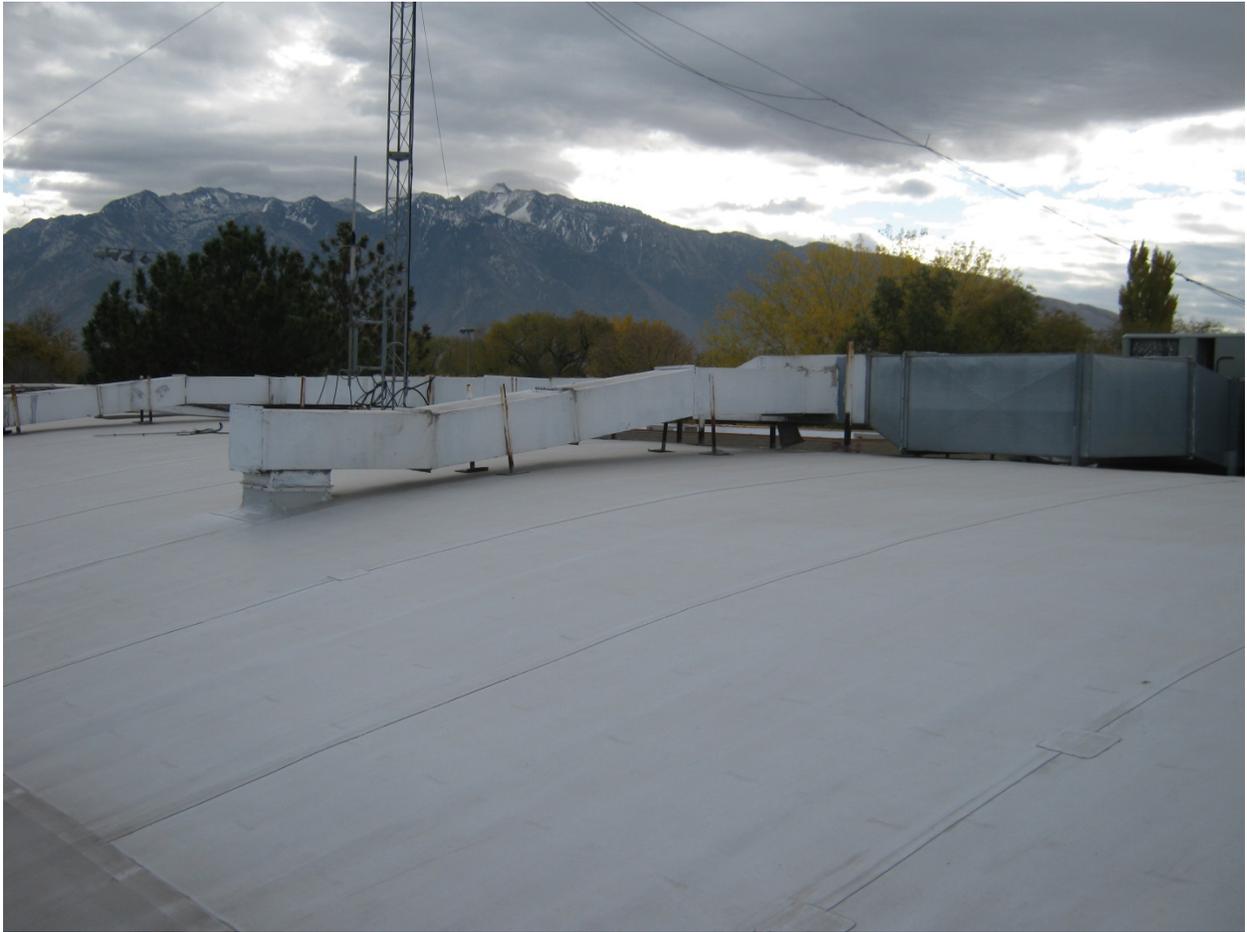
- The roof condition remains about the same and the same materials are present as in the 2008 report. The membrane on the gymnasium roof remains in good condition. *(see Image # 11)* The vents are still used. The skylight was painted over on the interior for aesthetic purposes, to block the deteriorated condition of the skylight. *(see Image # 12)*

Images 11: The roof membrane on the gymnasium wing is still in good condition.

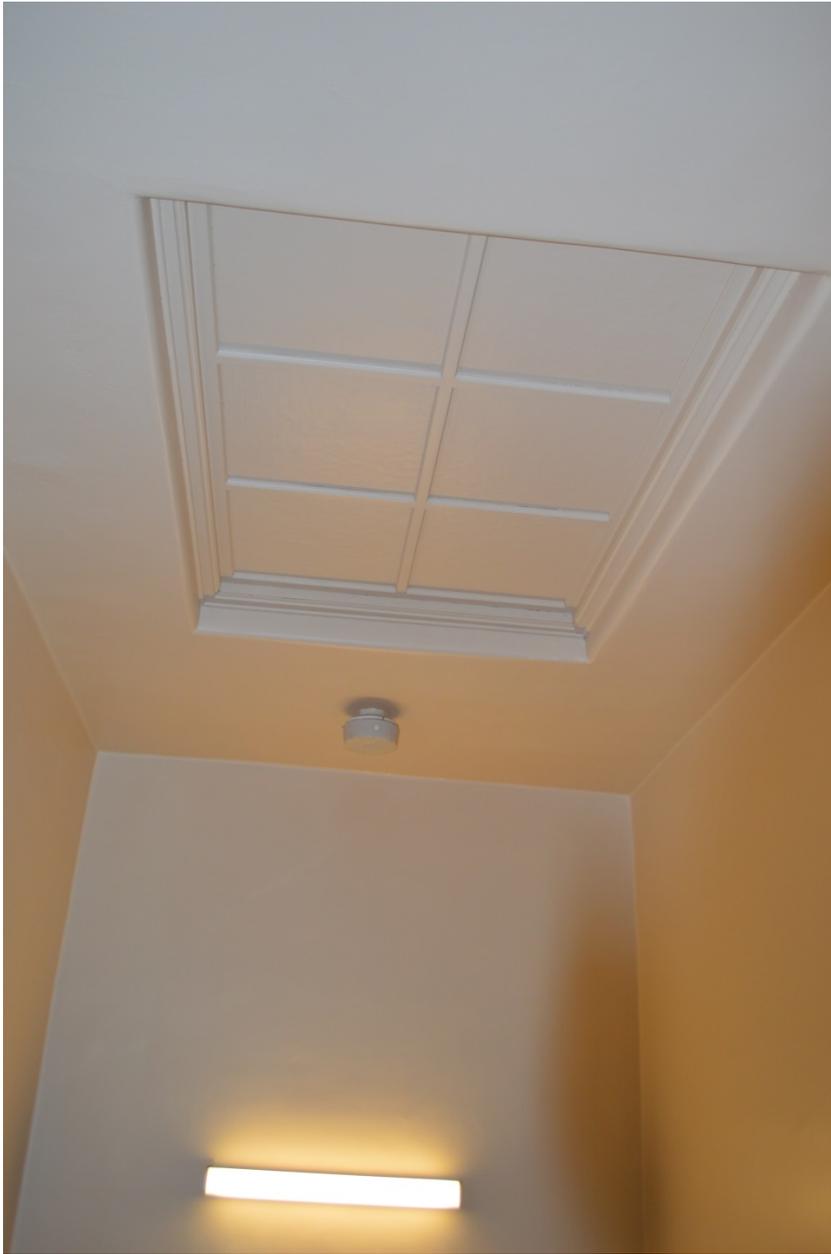
Images 12: The interior glass of the skylight has been painted over, for aesthetic purposes (the skylight is in need of repair/replacement).

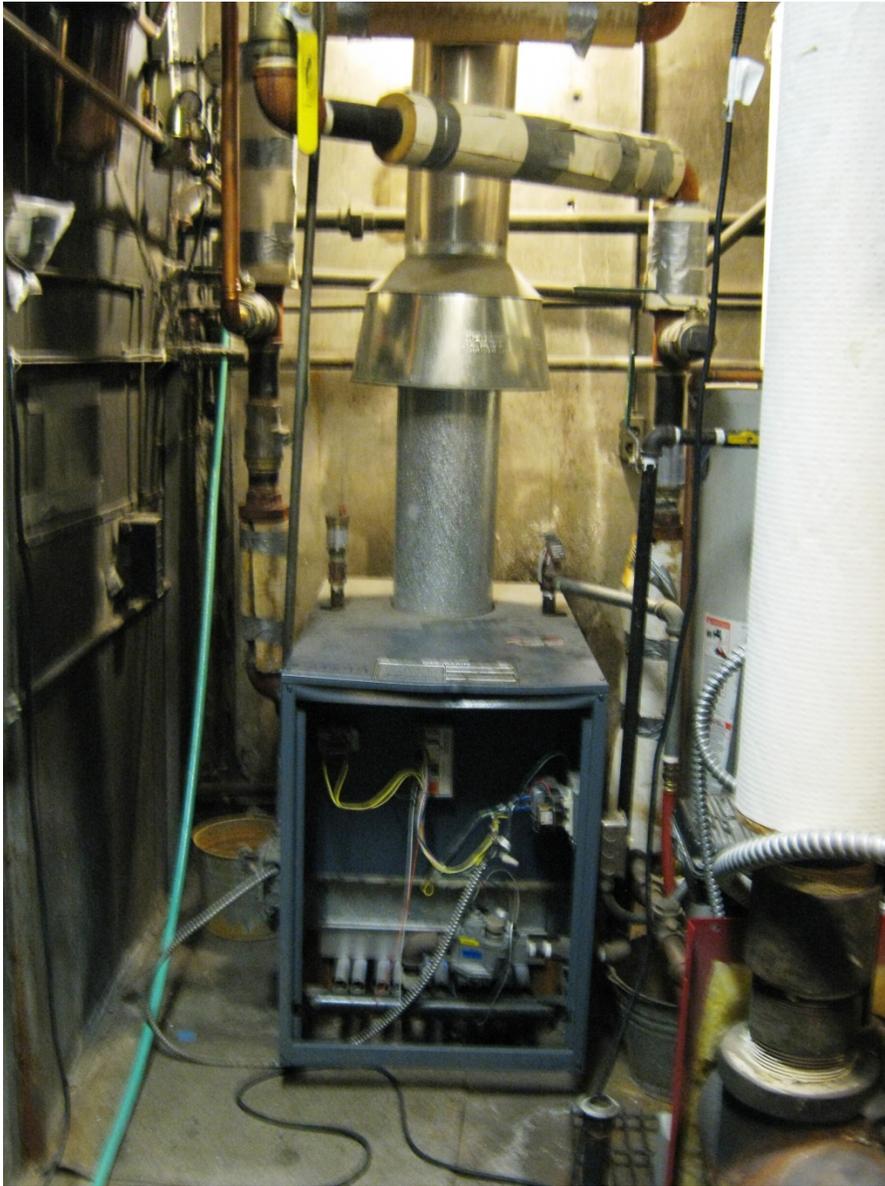
- The steam boiler was de-commissioned in 2011/2012. The steam boiler itself was still functional, but leaks were occurring in the steam tunnel, which runs around the perimeter of the building. Repair was felt to be too tricky due to the tight space and presence of hazardous materials. The pipe and pipe fittings in the tunnel were identified as asbestos-containing materials during the 2008 report. *(see Image # 13)*
- A new furnace was put in to replace the steam boiler.
- The system is still a two pipe system with no variable flow. A variable system is considered a high priority for updating the function of the building.

Images 13: The steam boiler was decommissioned and a new furnace installed.

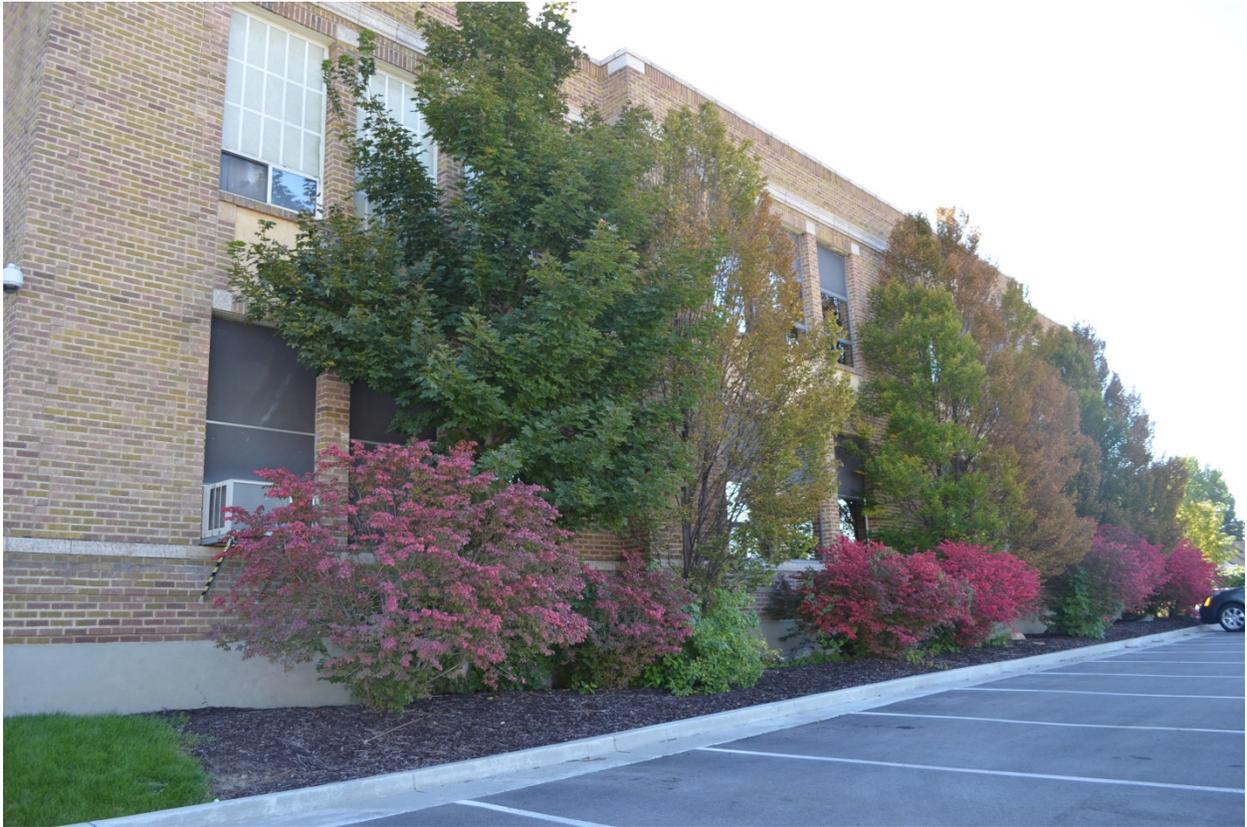
Images 14: A new parking lot to the west of the building was installed as part of the site improvements when the Boys and Girls Club building was constructed. A mechanical tunnel running westward from the building contained hazardous materials; this was abated and closed during the parking lot construction process.

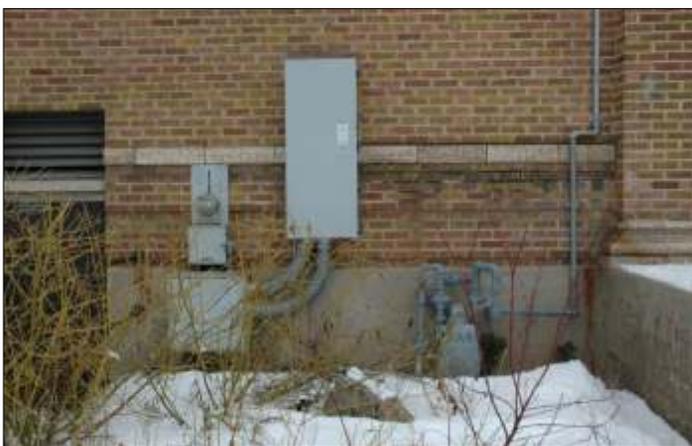
Due to their location below grade, footings could not be inspected. Original drawings show concrete footings of sufficient size to support gravity loads. Concrete foundations appear to be in good physical condition, except for the presence of fungal and/or microbial growth (mold, mildew, lichens, etc.). No substantial deterioration or failure of the plaster finish was observed.

The concrete foundation is in good condition, with no substantial deterioration of the plaster finish.

Additional footings and appropriate connections between existing and new footings may be necessary for a complete seismic upgrade. (See structural evaluation below.) Foundation cleaning should be completed concurrent with the masonry cleaning and restoration described below. At that time, deteriorated plaster may also be repaired, if it occurs.

of this report, it is recommended that future foundation planting and irrigation be limited. This will keep irrigation water away from the foundation and exterior walls and will help prevent excessive moisture infiltration. A no-irrigation zone of at least three feet from the foundation is recommended.

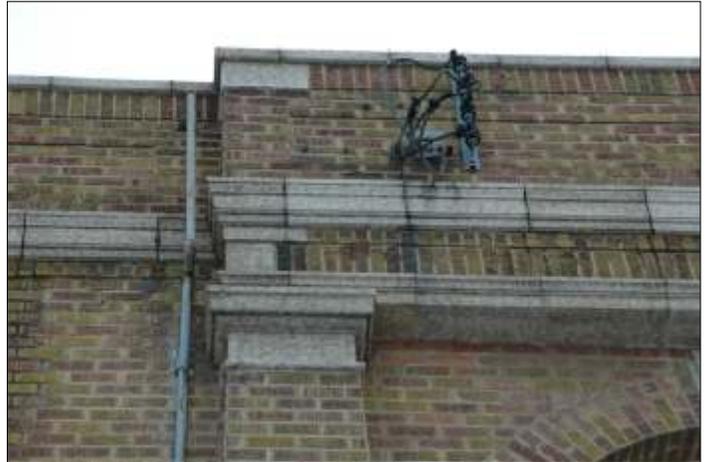
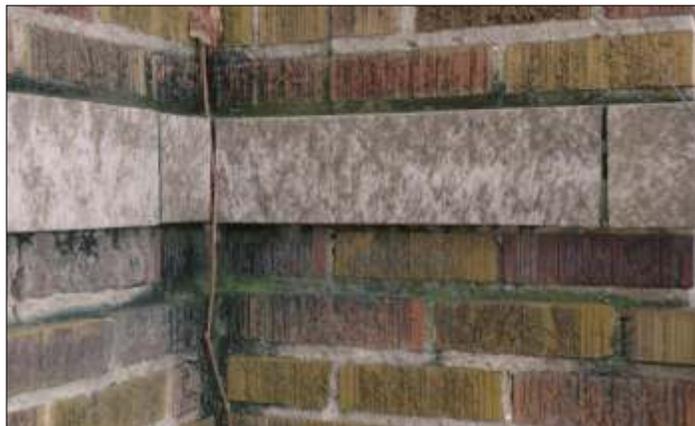
The same fungal and microbial growth observed at the exposed concrete foundation is apparent on the bricks and mortar, with very little occurring at the terra cotta itself. However, the mortar at the terra cotta is also susceptible to these conditions. There is considerable staining below the entire upper terra cotta cornice or belt course, that appears to be due to the failure of the mortar at the vertical joints between units. Otherwise, the masonry is in very good condition. Minor cracks are visible as noted above.

There is some evidence of fungal and microbial growth on the bricks and mortar that should be cleaned by a contractor that specializes in historic masonry buildings.

thorough rinsing using a low-pressure water spray unit. The masonry restoration and cleaning contractor may have other recommendations for further removing and cleaning fungi and/or microbial growth. Finally, a breathable sealer should be applied to protect the masonry from moisture and from the accumulation of soil, fungi and microbes.

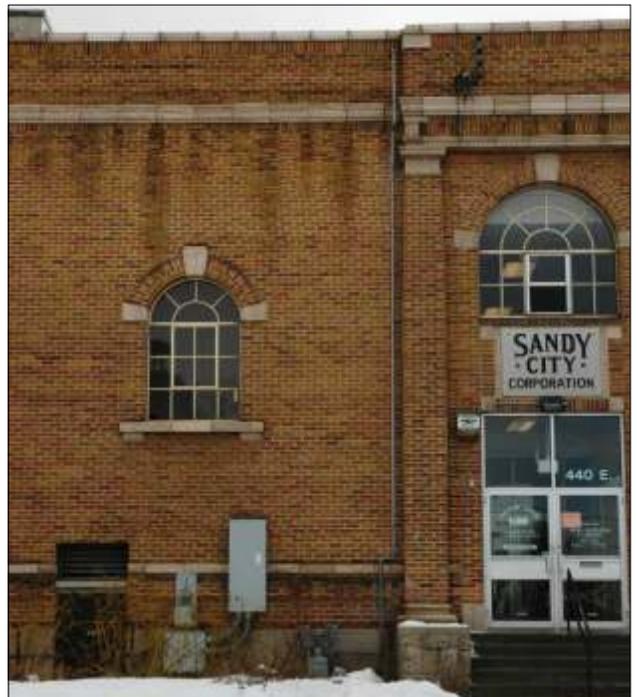
Top, Above: Visible staining below the upper terra cotta belt course appears to be due to failure of the mortar between the vertical joints.

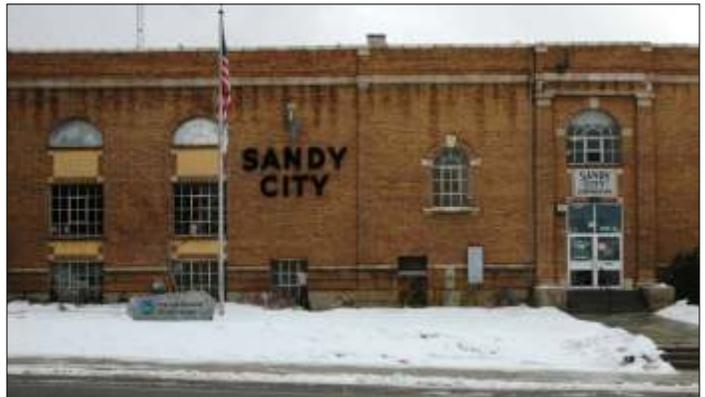
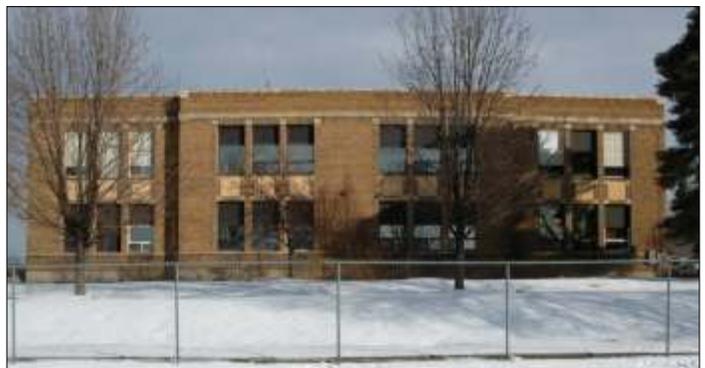
Original steel sash windows remain in much of the building (top), with the exception of the west elevation that has some modern replacement windows that only partially fill the original window opening (above).

Option 1: Refurbish existing doors and windows as necessary; replace broken glass and missing or deteriorated glazing putty and repair or fix in place any operable sashes.

most invasive from an historic preservation perspective. Complete window replacement is also likely to be more expensive than restoring the existing windows as described in Option 3. Option 3, then, is the preferred approach to window and door treatment.

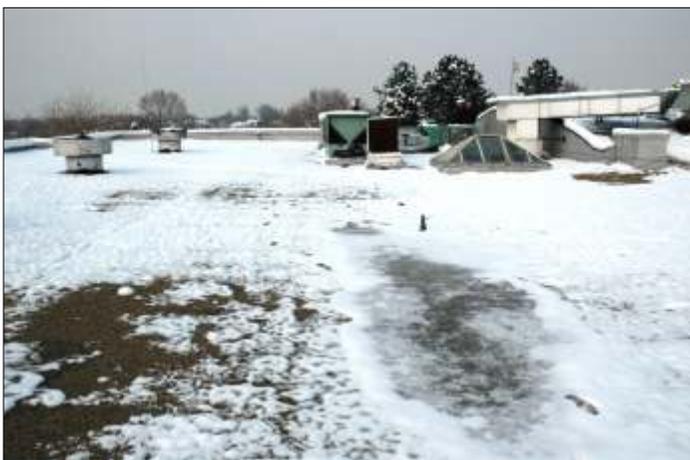
Areas of pooled water indicating insufficient slope toward the roof drains on the west classroom wing. Original gravity globe vents are no longer necessary and can be removed.

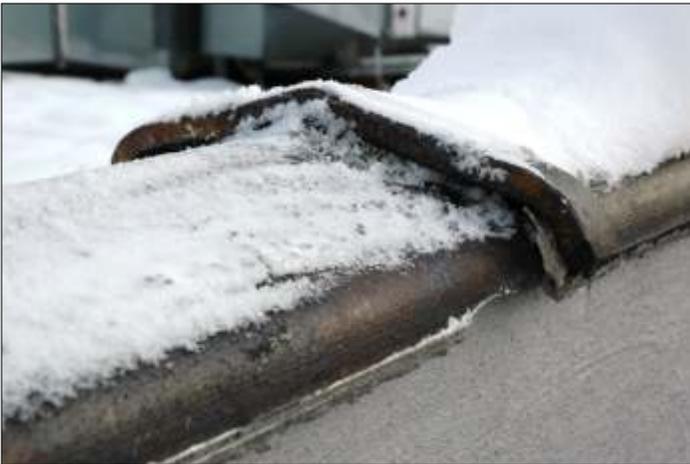
Although the mortar is deteriorating, terra cotta parapet tiles on the north wall of the gymnasium wing are themselves in fair condition.

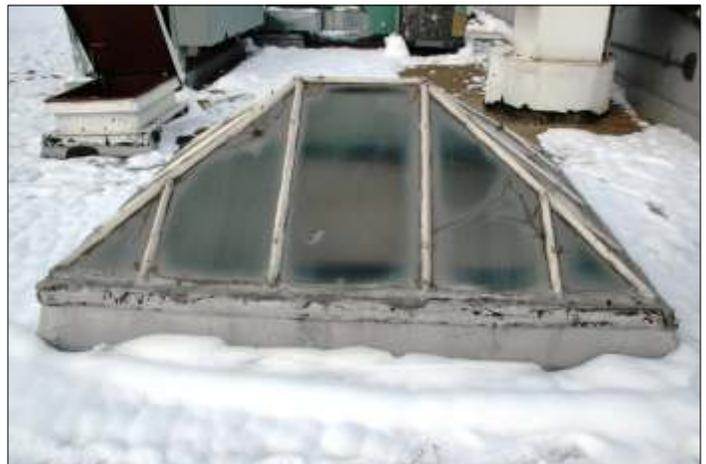
The remaining skylight is in poor condition, with loose flashings, deteriorated glazing putty and broken glass. The metal gravity vents are no longer necessary, even with the existing mechanical system, and would also be unnecessary for any replacement mechanical system.

One original hipped-roof skylight remains over the north stairwell but is in poor condition. Replacement skylights over both stairwells are recommended for natural daylight.

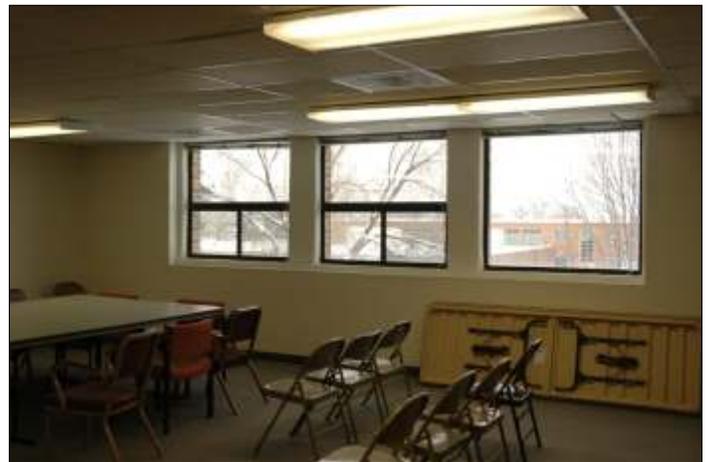
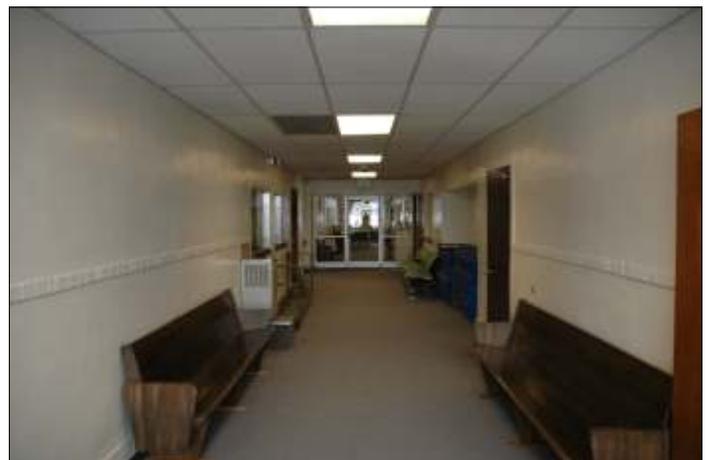
Carpet has been laid over the original floor finish in most classrooms and the corridors (top, above). A suspended acoustical tile system obscures the original tall ceilings.

With the level of future remodeling anticipated there is no compelling reason to preserve existing floor finishes, except perhaps in the gymnasium. New floor finishes might include some maple strip flooring to mimic the original floors, particularly in the corridors. Other finishes such as linoleum that are consistent with the period and type of original construction may also be considered.
