Property Report

9272 S 700 E, Sandy, UT 84070

Date: November 11, 2024

24046
REB

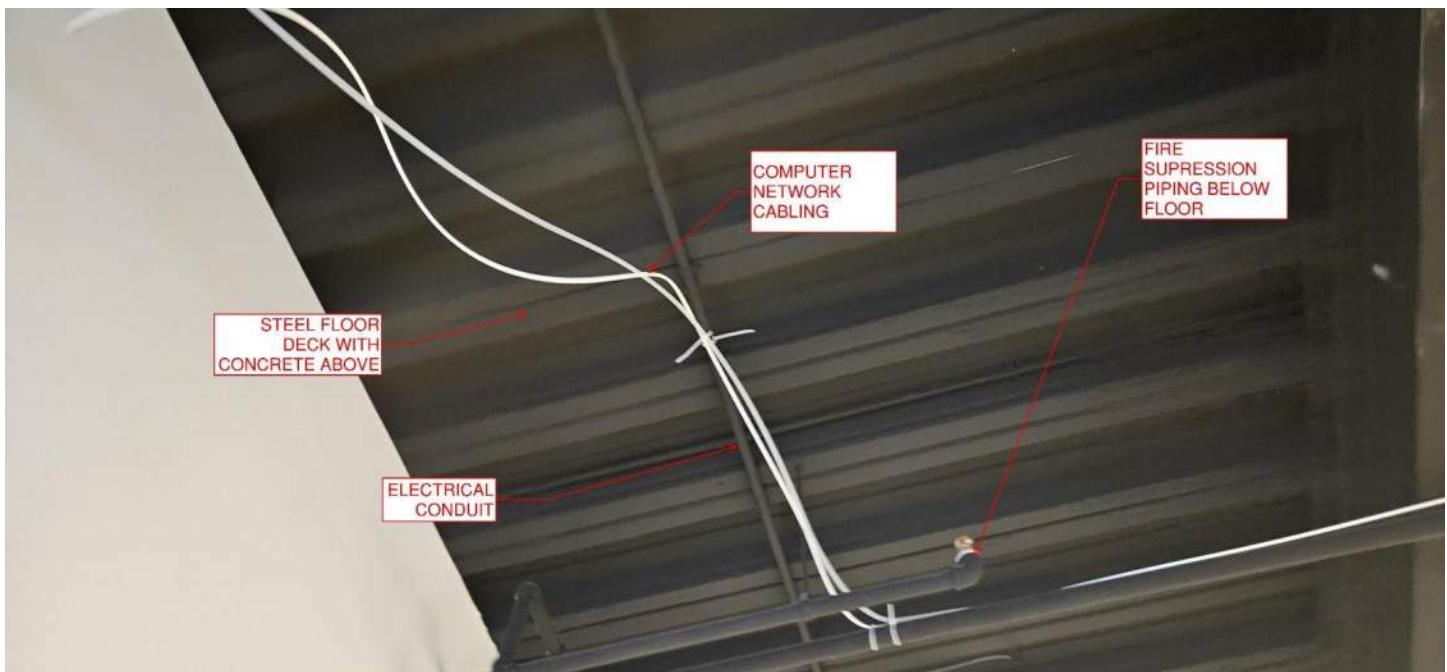
7. Networking systems are provided by cables pulling through the roof and floor framing systems. Much of this wiring is not contained in any conduit but hung by zip ties or across the ceiling tiles. We suggest that an IT professional investigate the current status of all wiring and connection boxes for conditions that need attention, as this is beyond the scope of our expertise. See Figure 15.

FIGURE 15 - CABLING AND FIRE SUPPRESSION PIPING

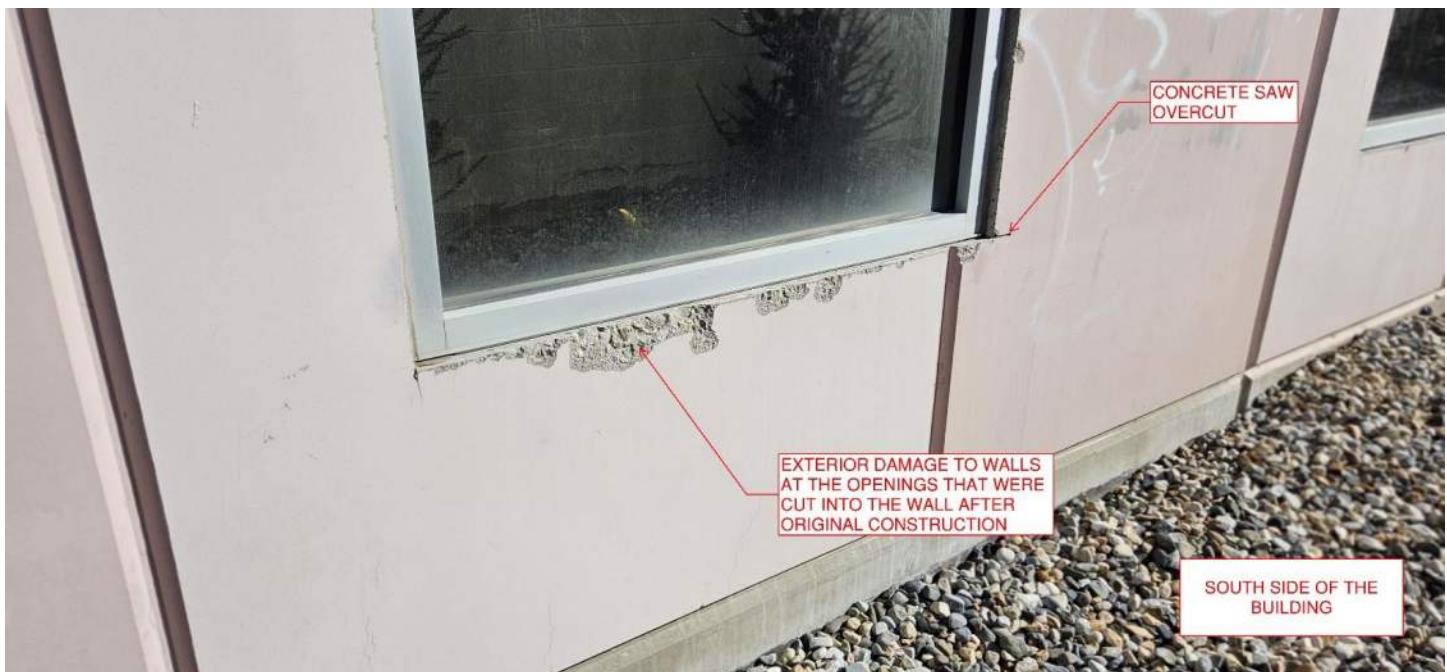
12. The exterior of much of the building is tilt-up concrete panels, which show almost no conditional deficiencies. The north is mainly glass, showing little if any, condition issues. We did, however, find where windows have been cut into the concrete panels on the south side, and there is some chipping of the concrete at the window saw cuts. There are also penetrations through the east parapet that need repairs; see Figures 20, 21 & 31.

FIGURE 20 - CHIPPING AT SOUTH WINDOW SAWCUTS

1. Parking lot crack sealing and resurfacing.
2. Patching of the exterior concrete panels at the south windows to prevent water intrusion into the panels and rusting the reinforcement.
3. Concrete patching of the holes in the east parapet where a previous sign appears to have been mounted to prevent water intrusion into the panels and rusting the reinforcement
4. We recommend removing unused satellite dishes and CMU blocks from the roof.

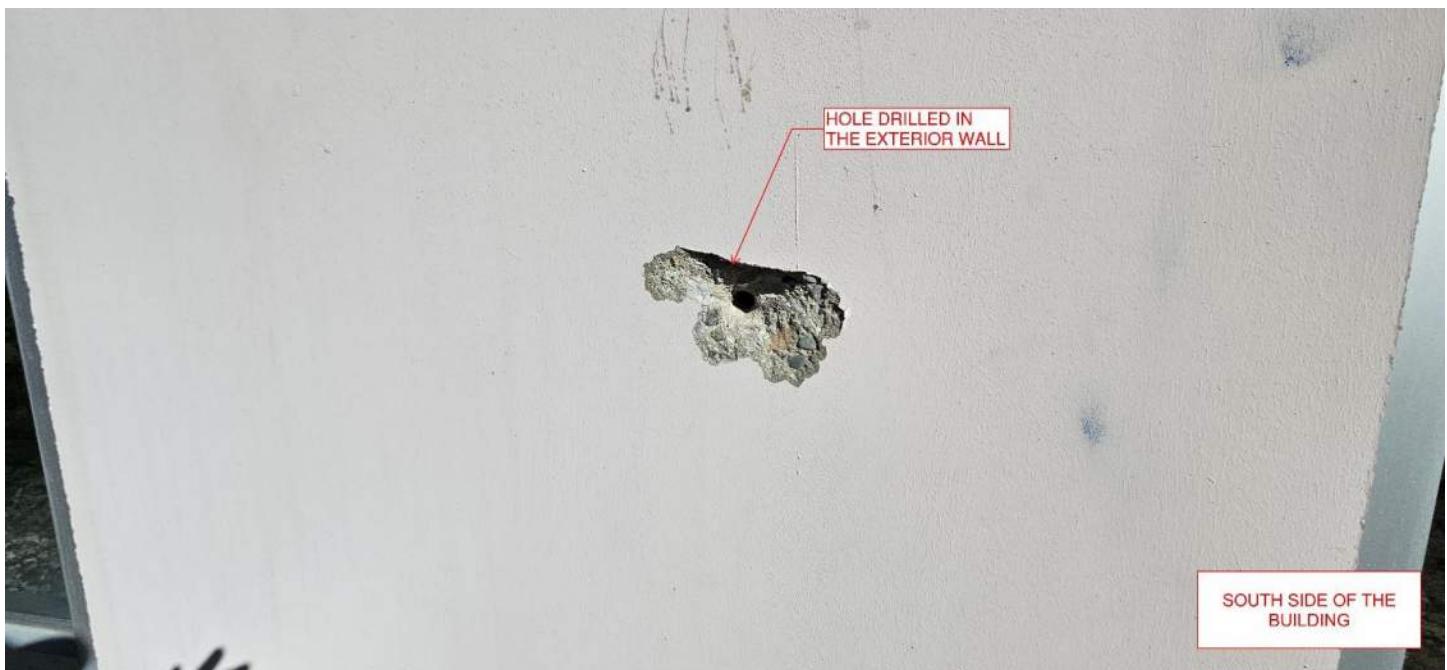
FIGURE 21 - WALL PENETRATION AT IN THE SOUTH WALL

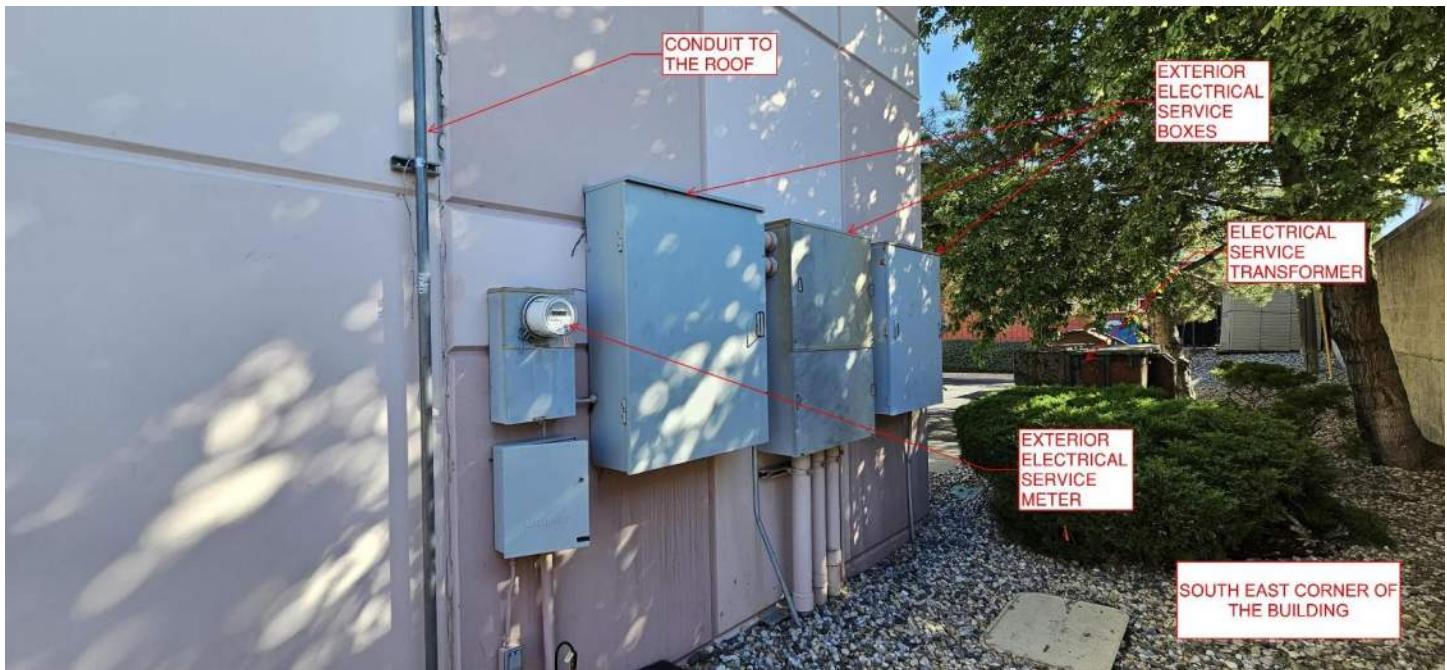
conduits, switches, lights, power outlets and breaker boxes for conditions that need attention, as this is beyond the scope of our expertise. Our only observation that brings anything into question is the condition of the power transformer outside the building. It shows weathering and rust damage on the exterior; only the power supply company with access can determine the existing condition if any repairs or maintenance is needed; see Figures 9, 15, 16 & 23.

FIGURE 23 - ELECTRICAL SERVICE PANELS

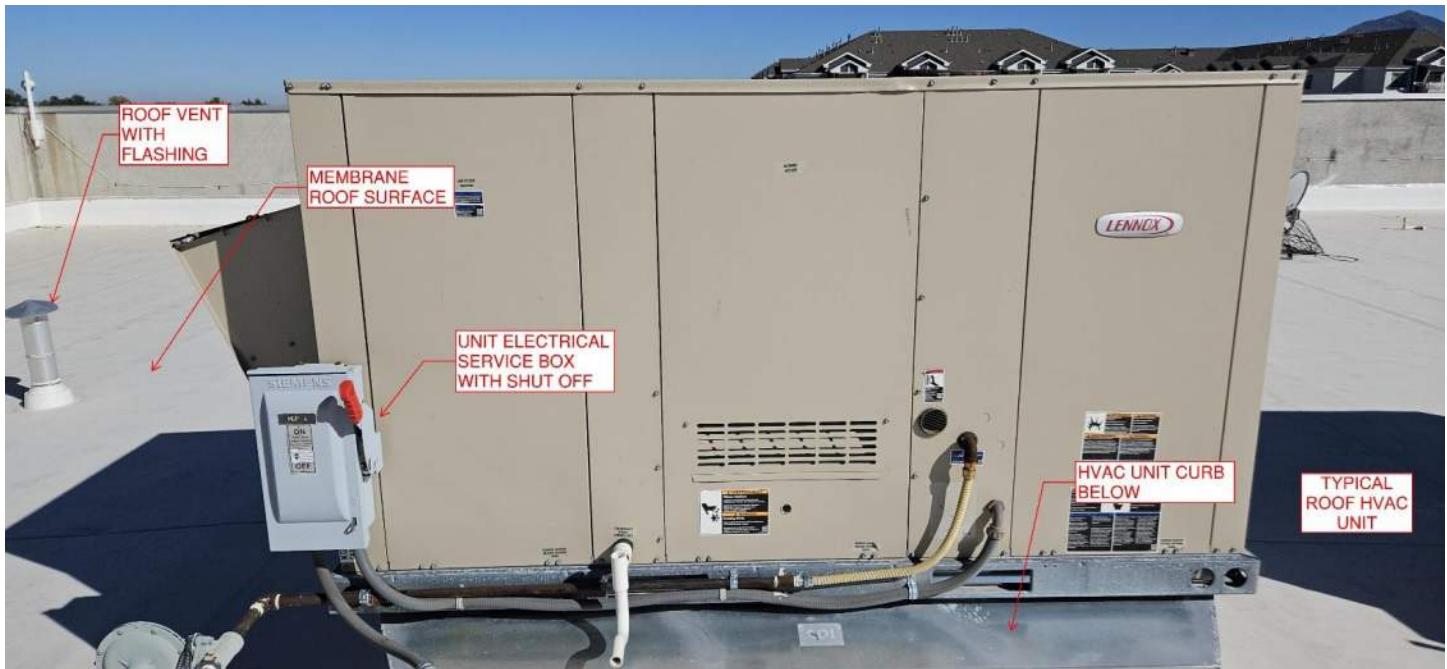
4. Mechanical systems such as HVAC units and duct work appear to be in good condition from an exterior view. These units have gas lines running to each unit on the roof, so we assume the units provide both heating and cooling. We suggest an HVAC technician investigate the current status of all units and ductwork for conditions that need attention, as this is beyond the scope of our expertise; see Figures 8, 9, 11, 14, 17, 24, 25 & 28.

FIGURE 24 - HVAC ROOFTOP UNIT

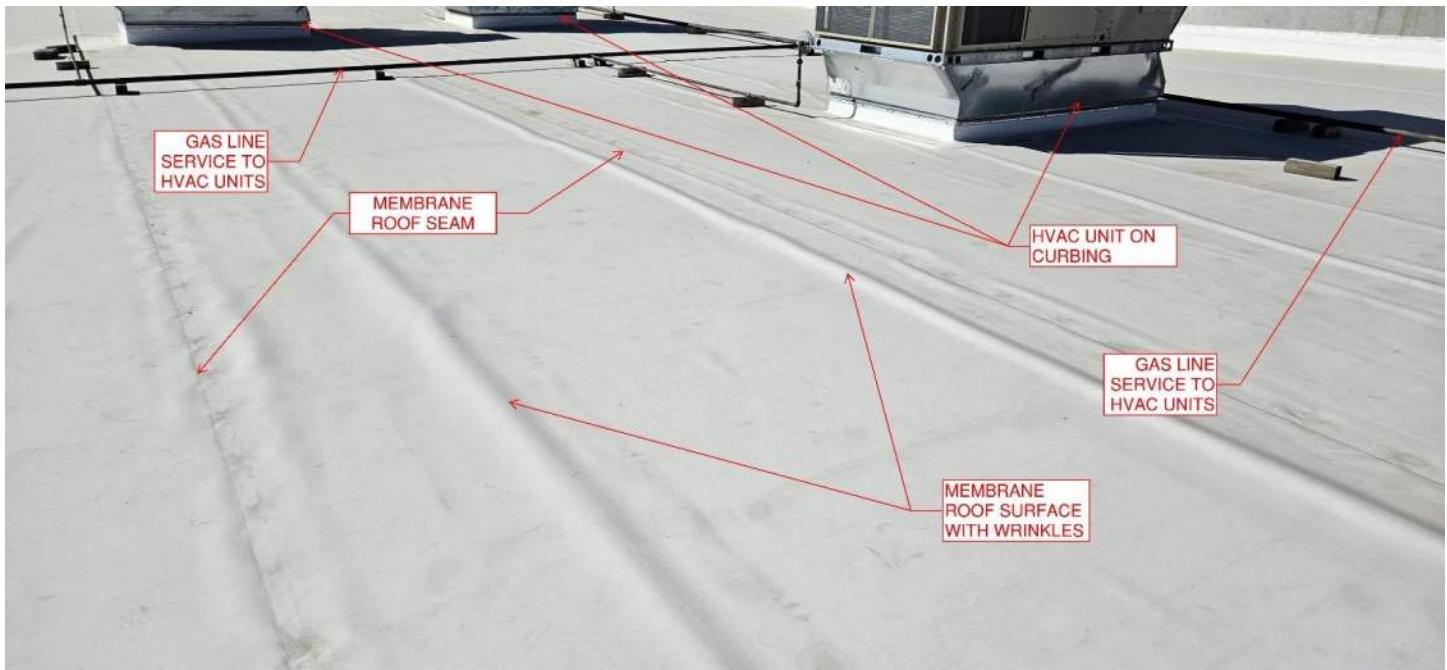
3. The roofing membrane is in good condition, with only minor water ponding areas. The seams appear sealed and flashing around mechanical unit curbs and vents, are in good condition. The roof drains remove the water as needed; see Figures 26 through 30.

FIGURE 26 - MEMBRANE ROOF

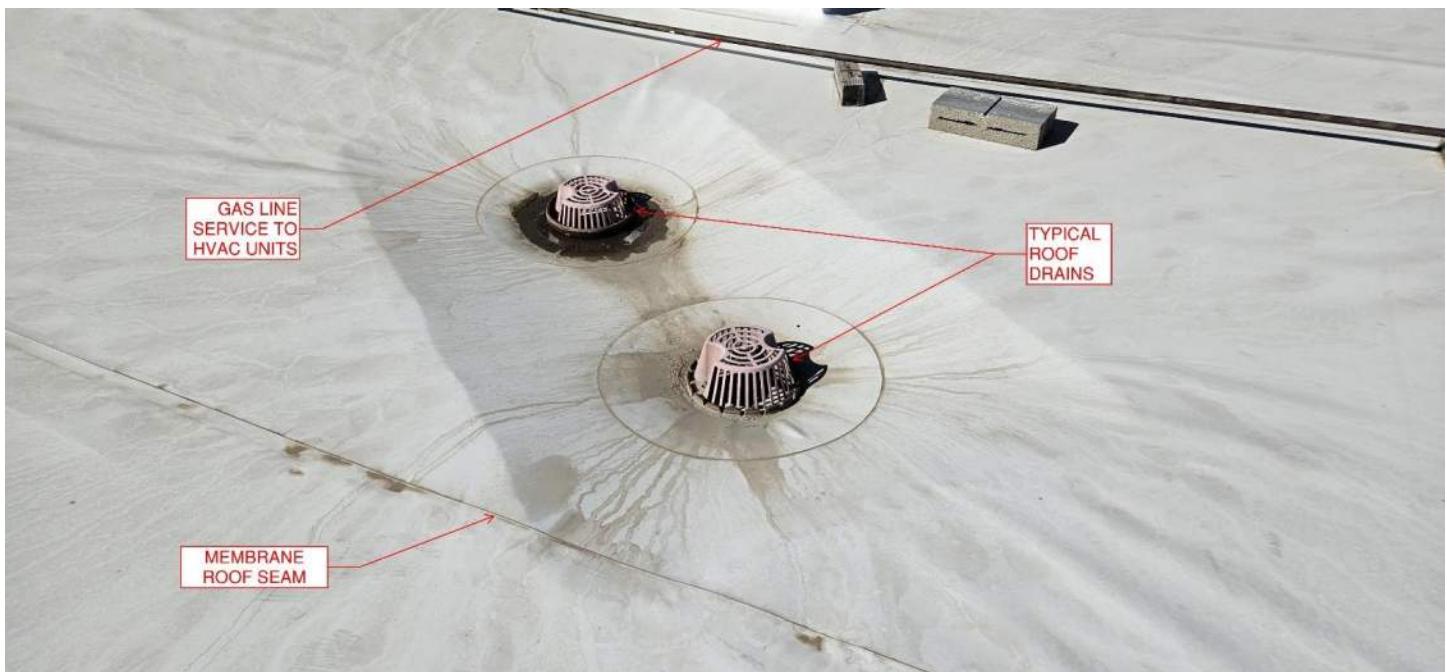
6. Plumbing systems, including roof drainage piping that could be viewed, appear to be in good condition from an exterior view. We could not find any excessive problems with water supply fixtures. The toilets and other drains are working as expected. We suggest a licensed plumber investigate the current status of all fixtures, toilets, and other water sources to be examined for leaks or conditions that need attention, as this is beyond the scope of our expertise; see Figures 10, 13, 15 & 27.

FIGURE 27 - ROOF DRAINS IN THE MEMBRANE ROOF

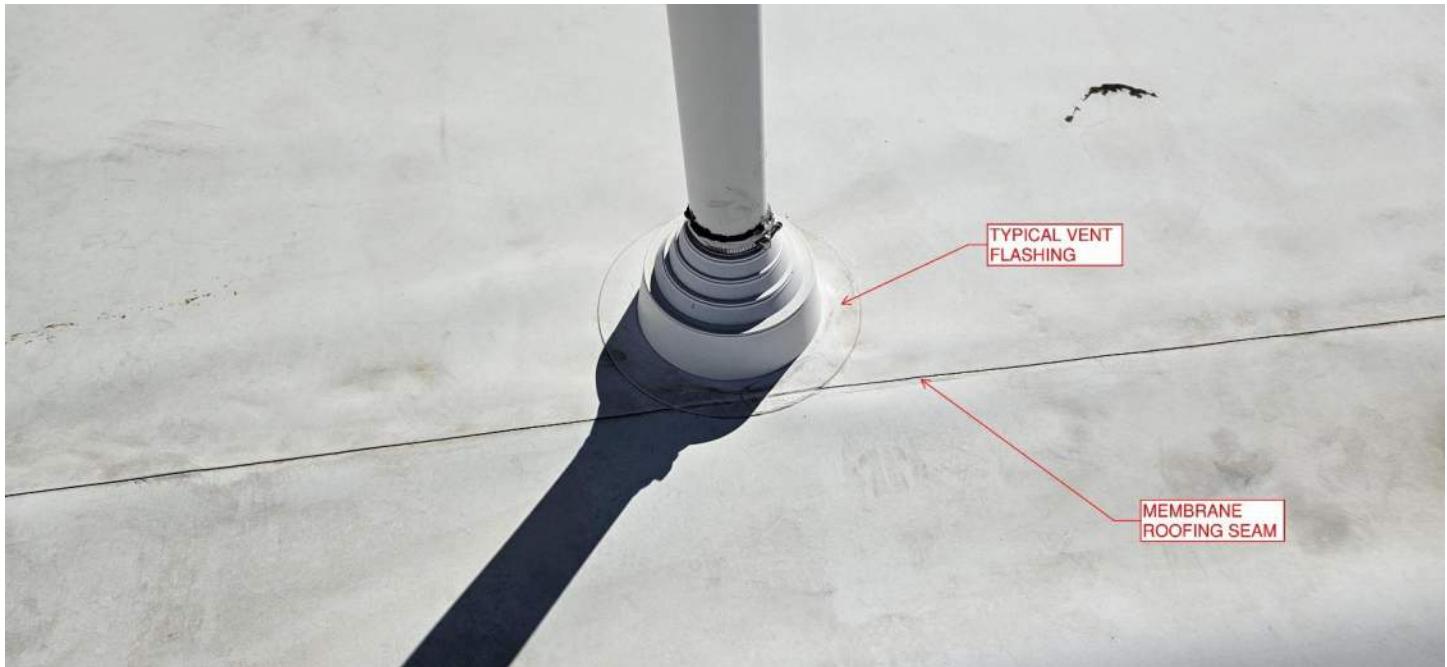
FIGURE 29 - TYPICAL VENT FLASHING

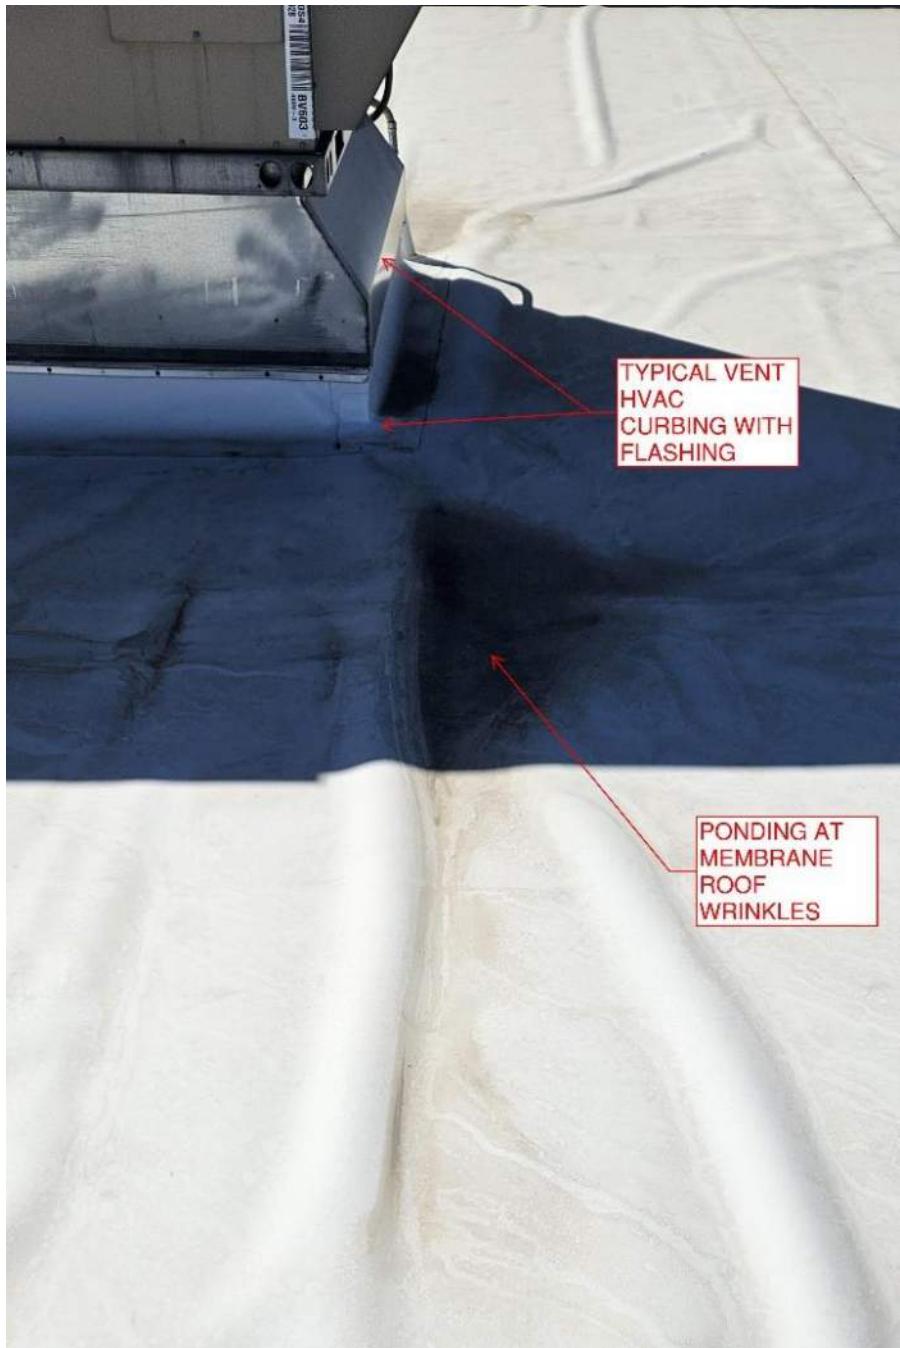
FIGURE 30 - MINOR PONDING ON THE MEMBRANE ROOF

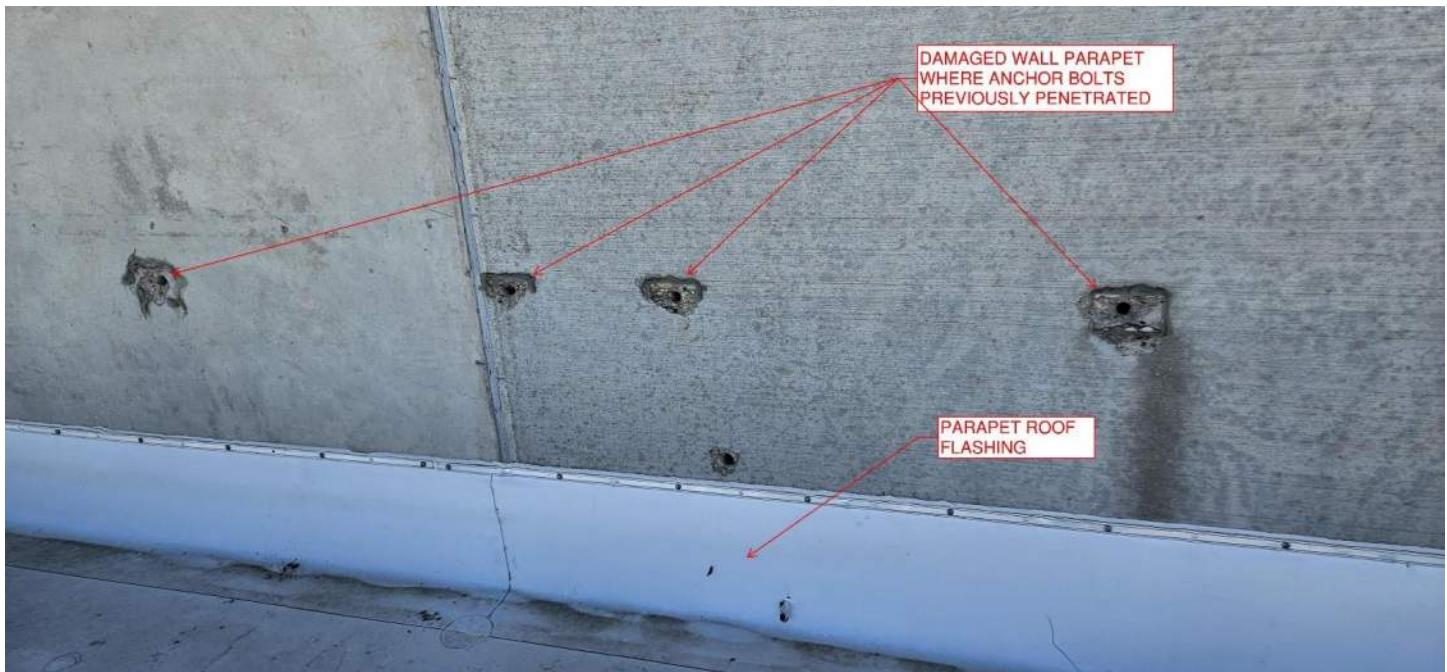
FIGURE 31 - WALL PENETRATIONS AT THE EAST PARAPET

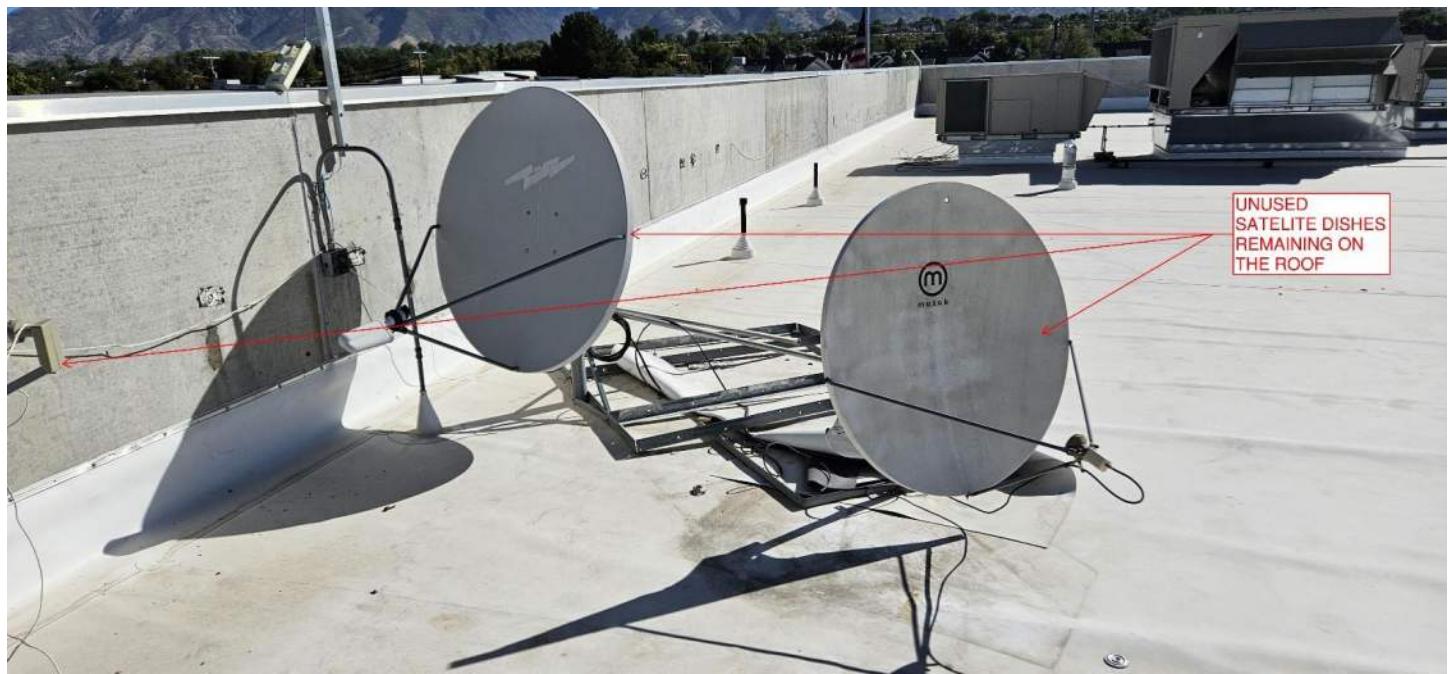
FIGURE 33 - UNUSED SATELLITE DISHES

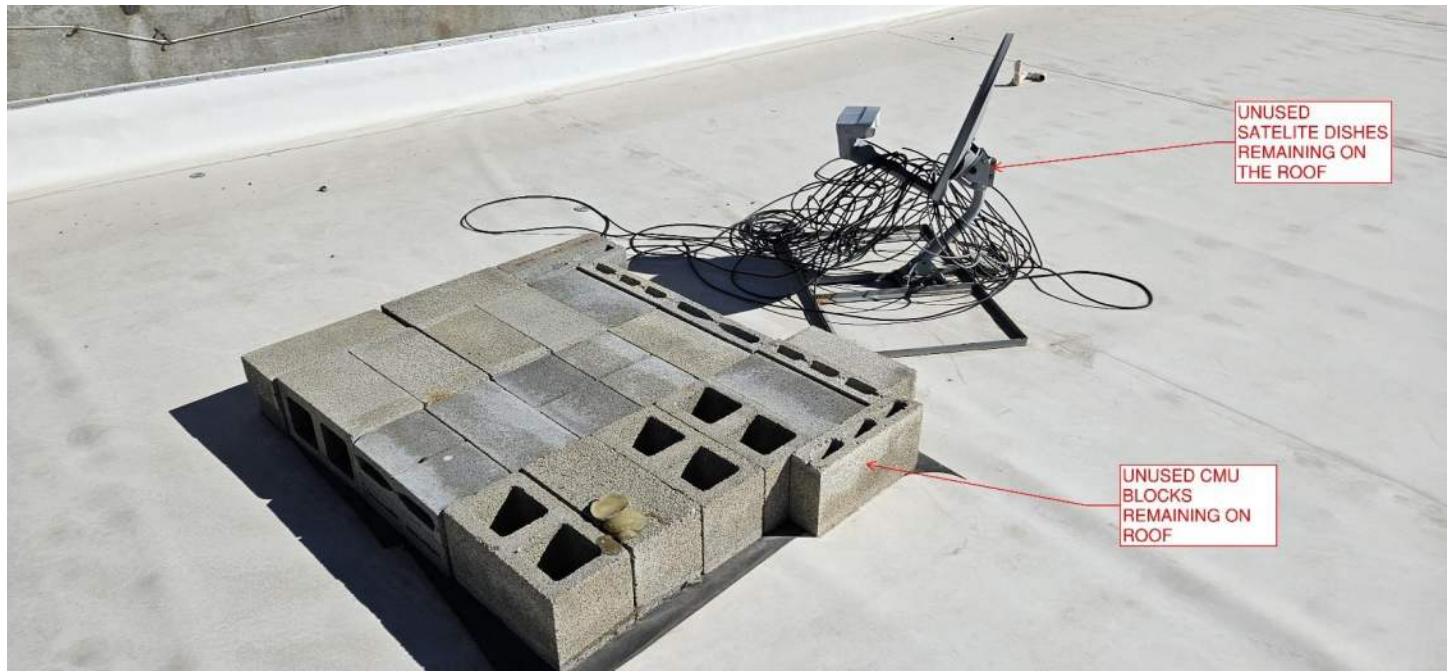
FIGURE 34 - UNUSED SATELLITE CMU PLATFORM AND DISH

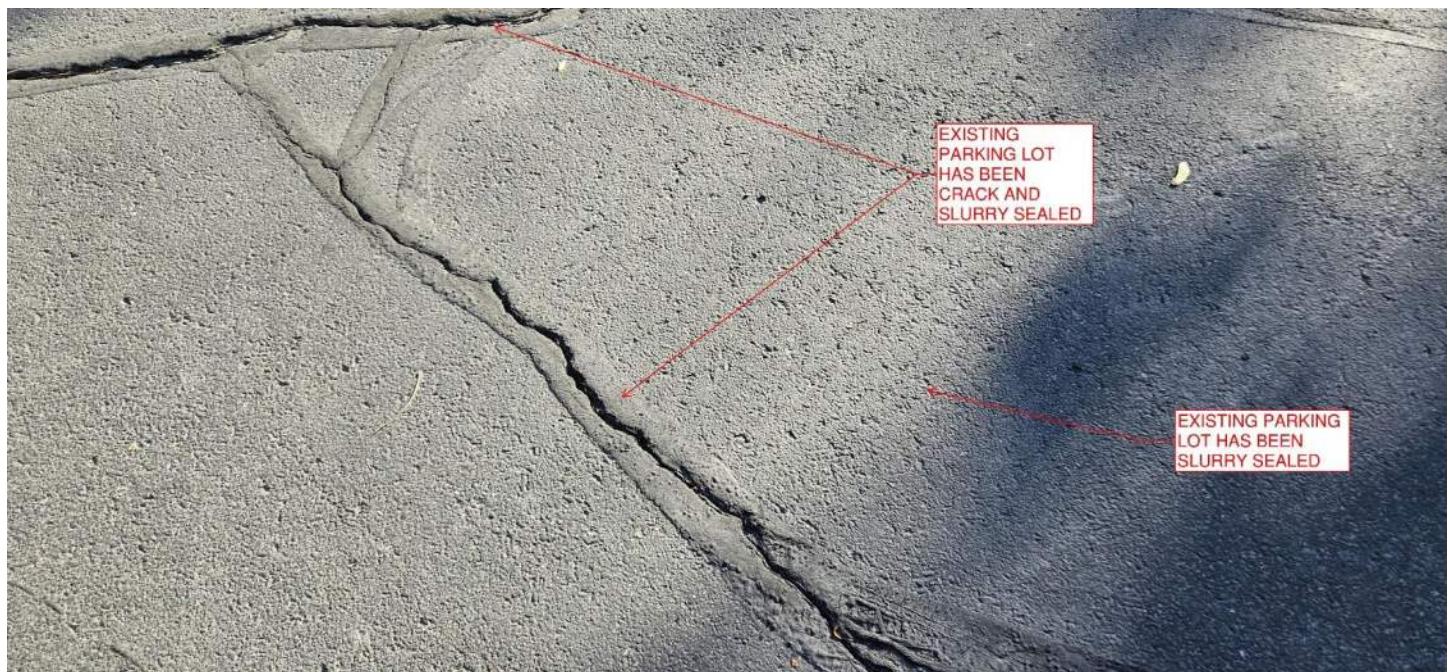
11. The parking lot shows extensive cracking that has been addressed using a crack sealing material, and a slurry seal-type coating has been applied in the past. The sidewalks, curbs, and approaches on the premises are in good working order, as are those around the property's perimeter, see Figures 1 & 35.

FIGURE 35 - EXISTING PARKING LOT CONDITION
