May 16, 2019

IGES Project No. 02441-005

Subject: Lock+Load Retaining Wall Construction Observation
Schneider Residence
3387 East 9980 South
Sandy, Utah

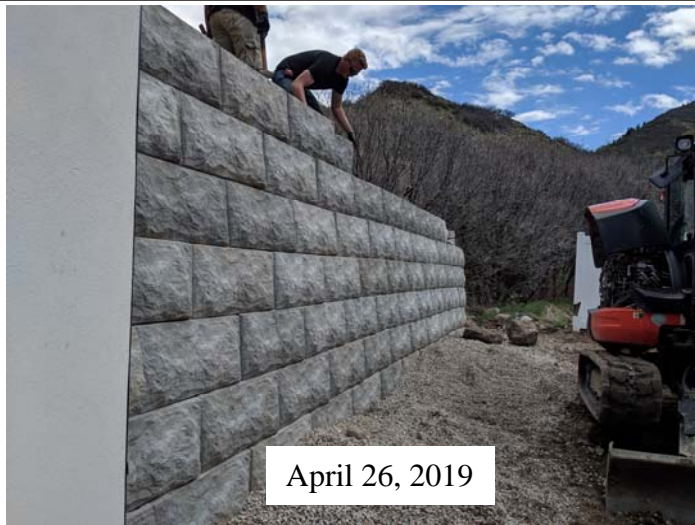
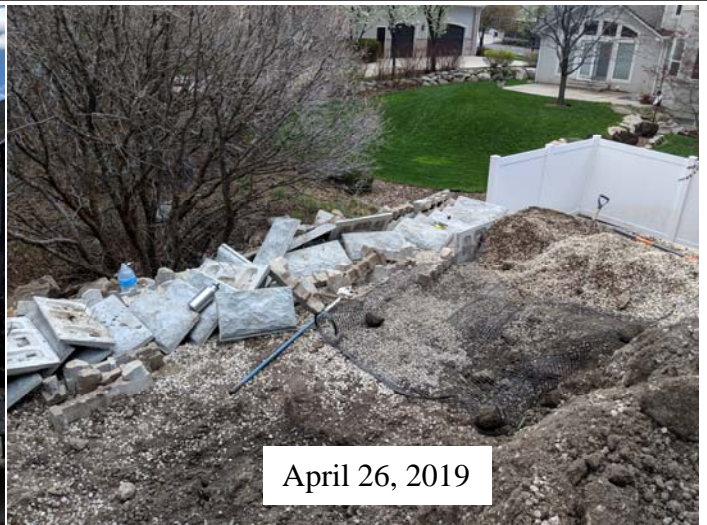
At the time of our site visit on April 26, 2019 the contractor had deconstructed the wall to a minimum total height of 6.7 feet (5 Panels) near the eastern property line. The wall had a maximum total height of 10.7 feet (8 Panels) at Station 10+00 where the retaining wall abuts against the home's foundation wall. At the time of our visit the contractor was placing the 6th panel course near Station 10+25. The geogrid observed behind the 6th panel course met the minimum required dimensions shown in the design package and the area between the back of the panel and the back of the counterfort was filled with free draining gravel. Some oversized material (cobbles greater than 6 inches in diameter) were observed in the structural fill that was stockpiled during the retaining wall deconstruction. During our visit IGES verbally recommended that this oversized material be removed from soil that will be used for retaining wall backfill. Starting near Station 10+25 and extending to about Station 10+50 we were informed by the Contractor (Ridgeline Excavating) that up to 5 courses of panels were planned

to be left in place. Several gaps up to ¾-inch wide were observed between the panels in this area, exposing drainage gravel.

After speaking with the Contractor, we understand that a 9th panel course is planned to be placed at Station 10+00. The initial design had a maximum exposed height of 8.8 feet (7 panels with 6 inches of embedment). IGES suggested the client could increase the maximum exposed height to 10.2 feet (8 panels with 6 inches of embedment or 9 panels with 22 inches of embedment) if an additional layer of geogrid was installed.

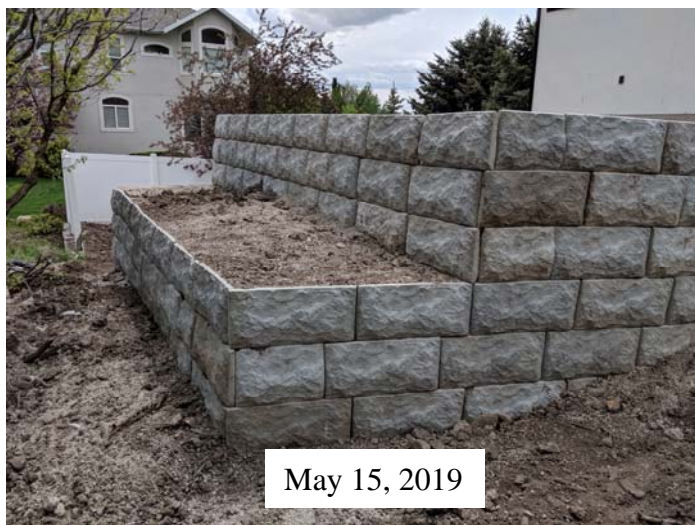
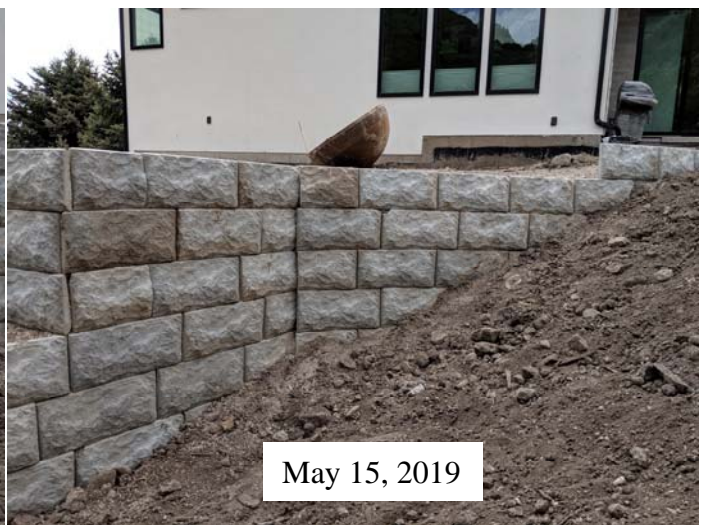
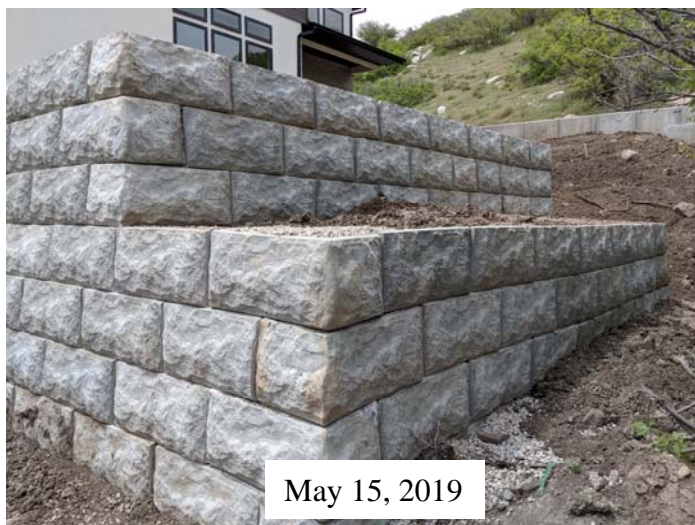
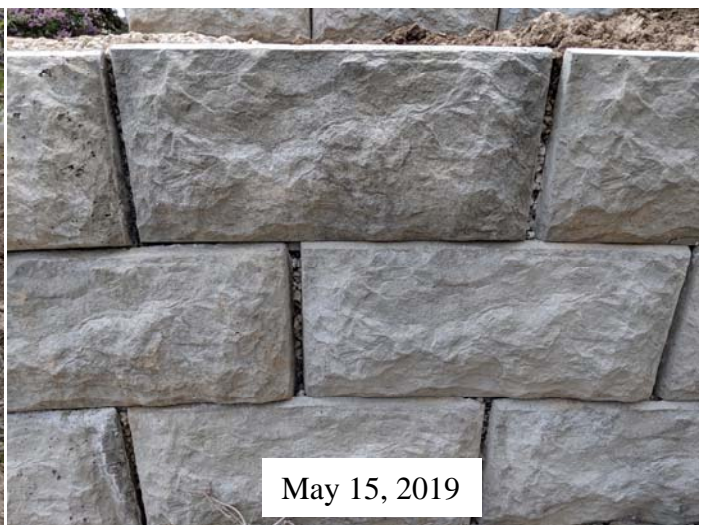
At the time of our site visit on May 15, 2019 the reconstruction of the Lock+Load retaining wall had been completed. The wall was split into two tiers between Stations 10+25 and 10+50. The wall was split to ensure the lower tier (which runs along the property line) did not exceed 5 feet exposed height. As recommended during our previous observation on April 26, 2019, the contractor placed material at the toe of the wall near Station 10+00 to maintain a maximum exposed height of less than 10.2 feet. Near Station 10+25 corner Lock+Load panels were used for the outside corner on both tiers. Near Station 10+50 there were additional outside corners on both tiers, however no corner Lock+Load panels were observed. Standard Lock+Load panels appeared to have been adjusted in the field to fit the outside corners in this area. These adjusted panels affected the quality of the running bond of the Lock+Load wall units primarily on the upper tier. The backfill soil behind both tiers had been compacted to within a few inches of the top of the Lock+Load panels. No geogrid or counterforts were observed during our site visit. Gaps between the Lock+Load panels were primarily observed on the lower tier. The gaps were up to ¾-inch wide and the drainage gravel behind the panels was observed at the face of the retaining wall.

- Gaps up to ¾-inch wide were observed between several panels. Drainage gravel was observed between these gaps in several locations.
- Rather than using the corner panels for the outside corners near Station 10+50 the standard Lock+Load panels were adjusted in the field. Due to these adjustments the running bond was not continued across the entire wall alignment. This does not comply with the guidance contained in the Lock+Load construction manual.
- The finish landscaping elements have not been installed.

The finished landscaping elements include installing 8 inches minimum of low permeable soil and vegetating or installing hardscape. We recommend that the finished landscaping elements be completed to bring the wall into compliance with the *design package*.
