# **Property Report**

**Alta Commercial Development LLC  
Brooke Hintze**

9272 S 700 E, Sandy, UT 84070

Date: November 11, 2024

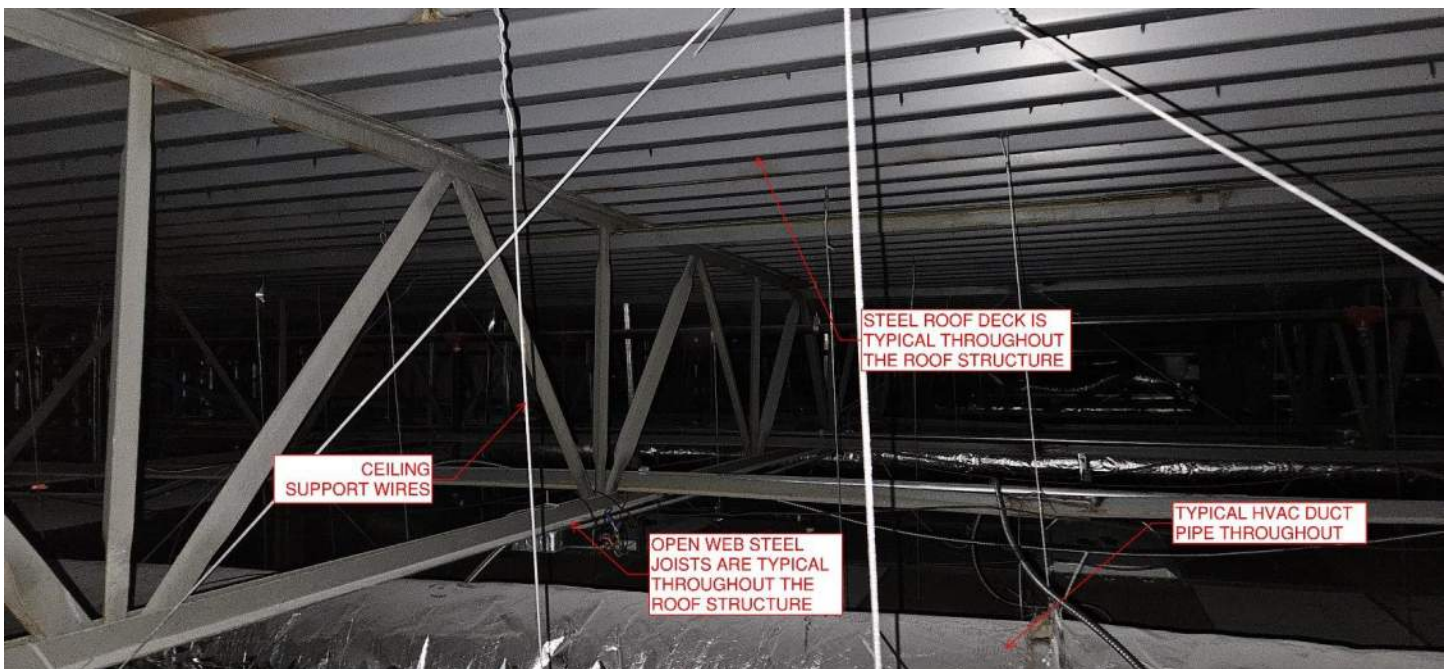
**FIGURE 7 - ROOF FRAMING**

1. The building was built in 2000, according to the [Salt Lake County Assessor](#).
2. The structural elements, which include the roof deck, open web roof trusses, open web floor trusses, and columns, are in good condition, as is expected for a building of this age. The foundation could not be observed as it is buried beneath the existing structure. However, the condition of the foundation system is not expected to be damaged or in need of repairs. See Figures 7 through 11.

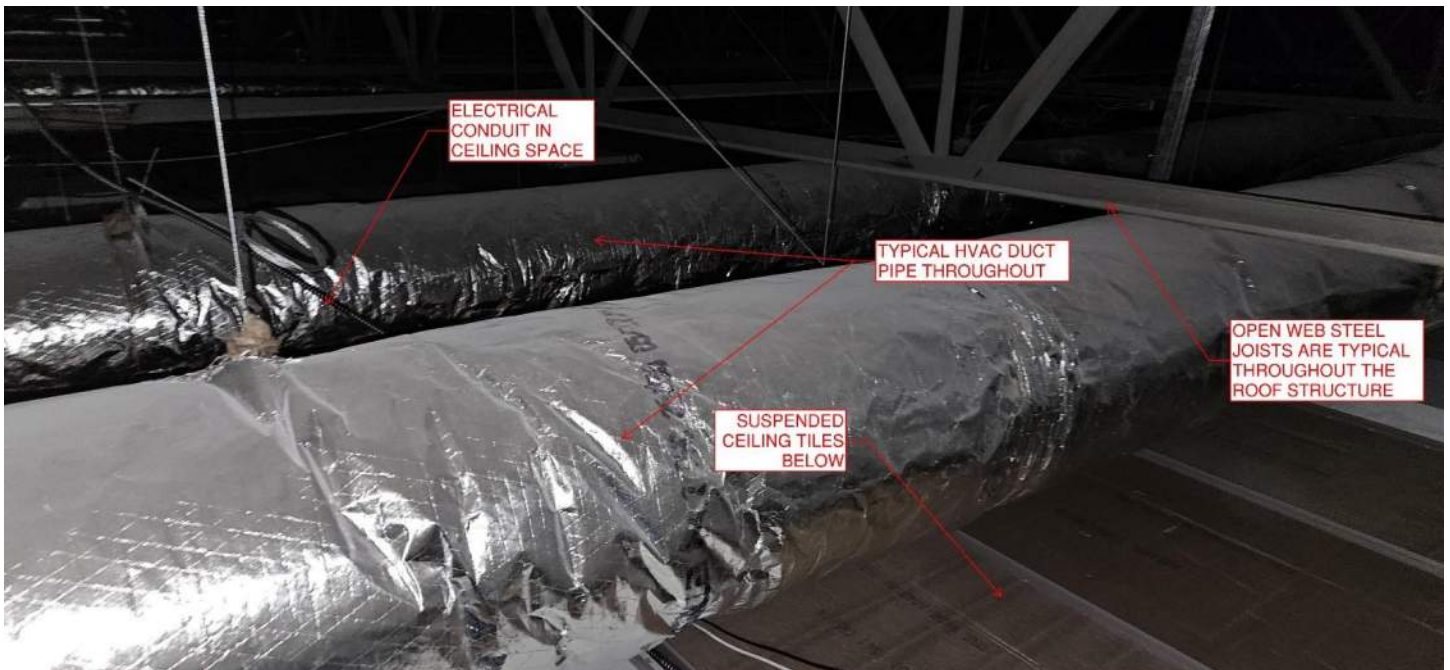
**FIGURE 8 - UPPER FLOOR CEILING SPACE**

4. Mechanical systems such as HVAC units and duct work appear to be in good condition from an exterior view. These units have gas lines running to each unit on the roof, so we assume the units provide both heating and cooling. We suggest an HVAC technician investigate the current status of all units and ductwork for conditions that need attention, as this is beyond the scope of our expertise; see Figures 8, 9, 11, 14, 17, 24, 25 & 28.

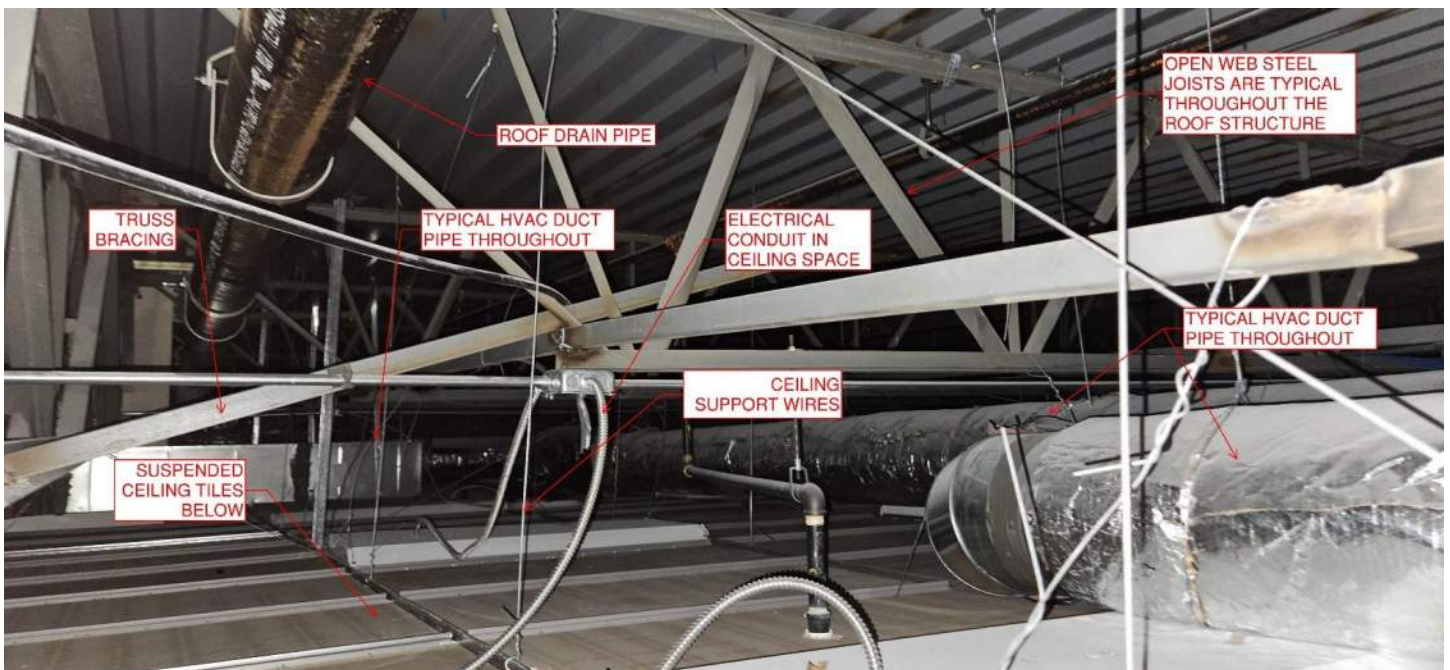
**FIGURE 9 - UPPER FLOOR CEILING SPACE**

conduits, switches, lights, power outlets and breaker boxes for conditions that need attention, as this is beyond the scope of our expertise. Our only observation that brings anything into question is the condition of the power transformer outside the building. It shows weathering and rust damage on the exterior; only the power supply company with access can determine the existing condition if any repairs or maintenance is needed; see Figures 9, 15, 16 & 23.

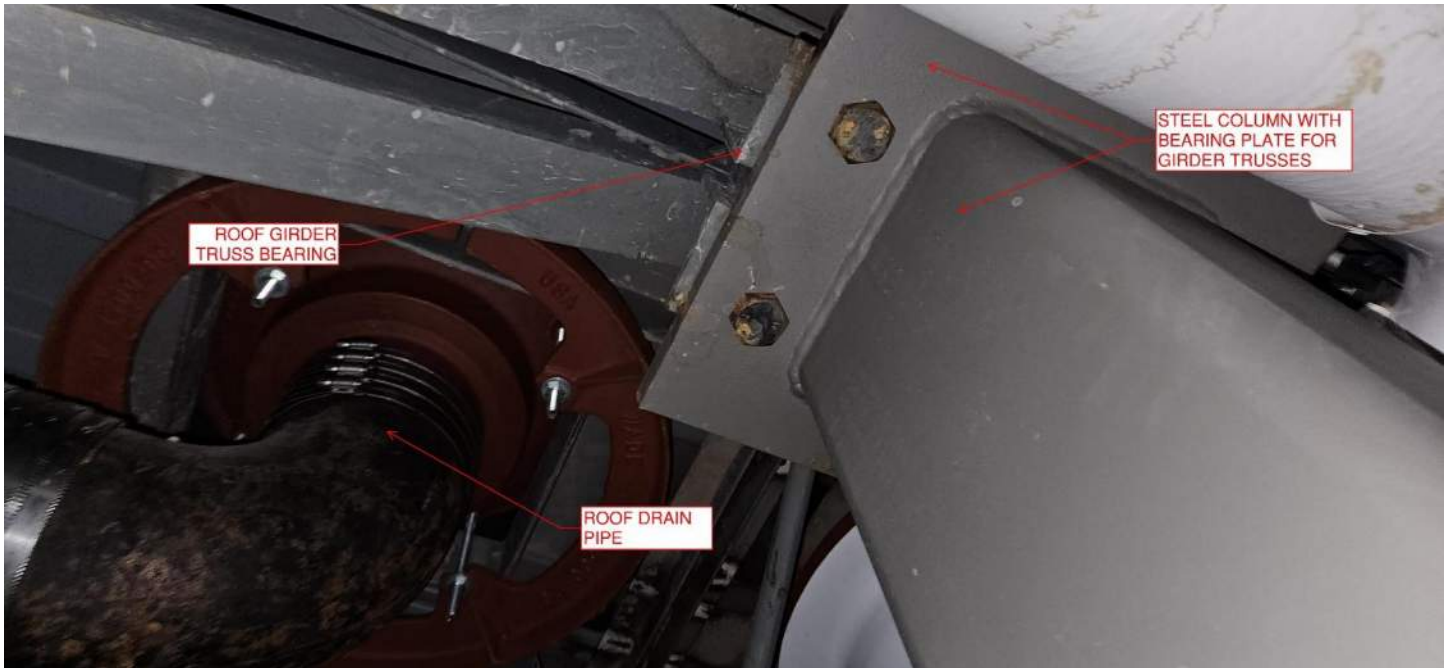
**FIGURE 10 - GIRDER TO COLUMN CONNECTION**

6. Plumbing systems, including roof drainage piping that could be viewed, appear to be in good condition from an exterior view. We could not find any excessive problems with water supply fixtures. The toilets and other drains are working as expected. We suggest a licensed plumber investigate the current status of all fixtures, toilets, and other water sources to be examined for leaks or conditions that need attention, as this is beyond the scope of our expertise; see Figures 10, 13, 15 & 27.

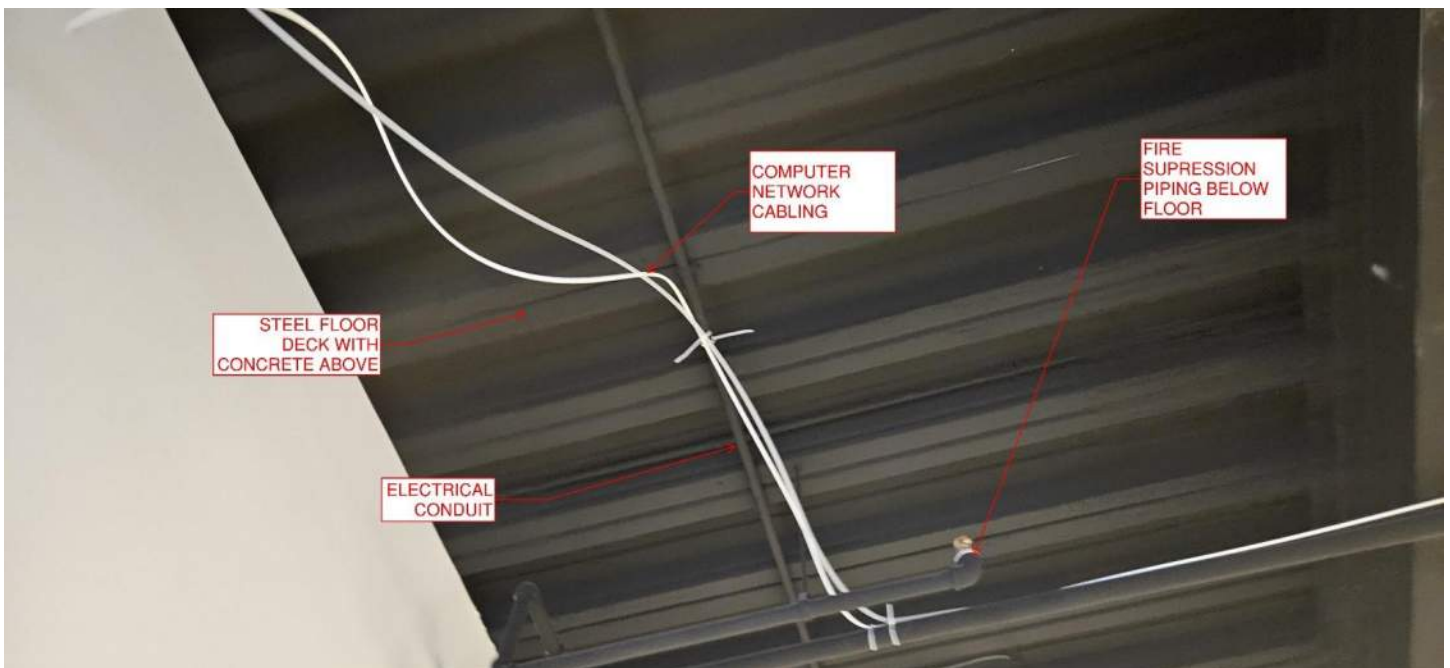
**FIGURE 15 - CABLING AND FIRE SUPPRESSION PIPING**

7. Networking systems are provided by cables pulling through the roof and floor framing systems. Much of this wiring is not contained in any conduit but hung by zip ties or across the ceiling tiles. We suggest that an IT professional investigate the current status of all wiring and connection boxes for conditions that need attention, as this is beyond the scope of our expertise. See Figure 15.

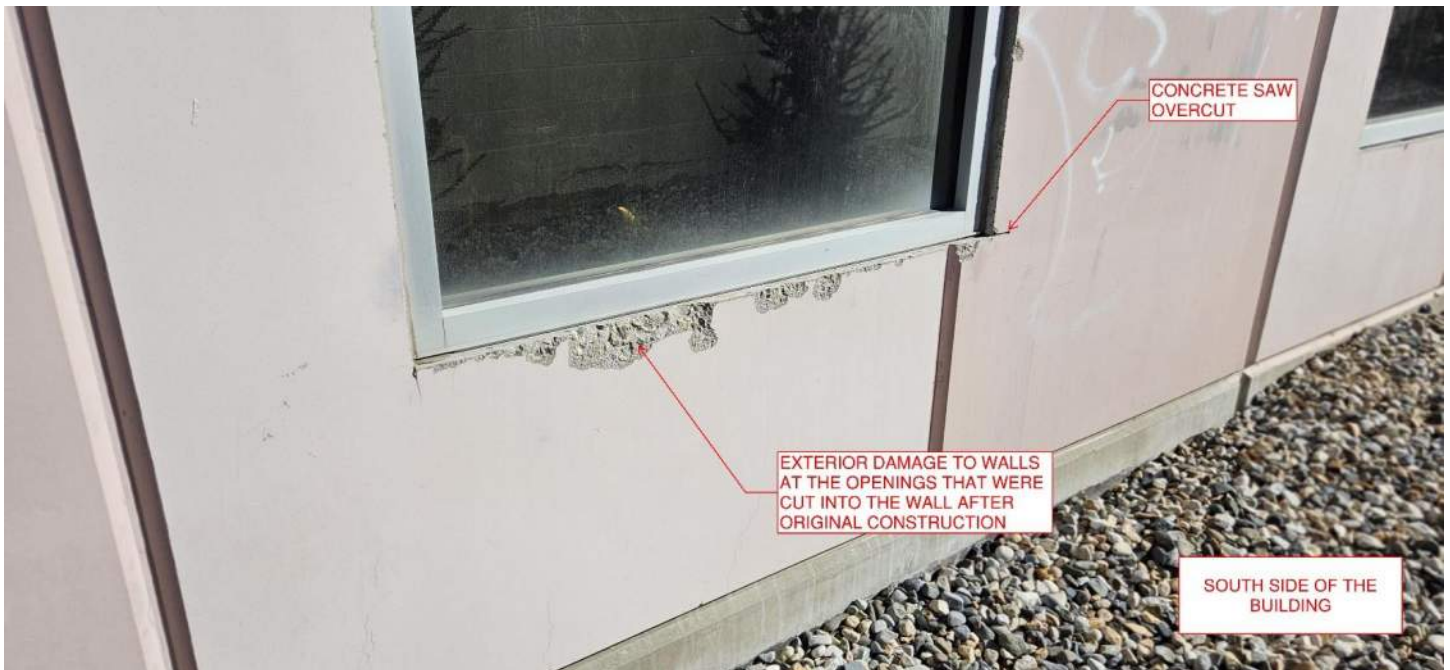
12. The exterior of much of the building is tilt-up concrete panels, which show almost no conditional deficiencies. The north is mainly glass, showing little if any, condition issues. We did, however, find where windows have been cut into the concrete panels on the south side, and there is some chipping of the concrete at the window saw cuts. There are also penetrations through the east parapet that need repairs; see Figures 20, 21 & 31.

**FIGURE 20 - CHIPPING AT SOUTH WINDOW SAWCUTS**

1. Parking lot crack sealing and resurfacing.
2. Patching of the exterior concrete panels at the south windows to prevent water intrusion into the panels and rusting the reinforcement.
3. Concrete patching of the holes in the east parapet where a previous sign appears to have been mounted to prevent water intrusion into the panels and rusting the reinforcement
4. We recommend removing unused satellite dishes and CMU blocks from the roof.

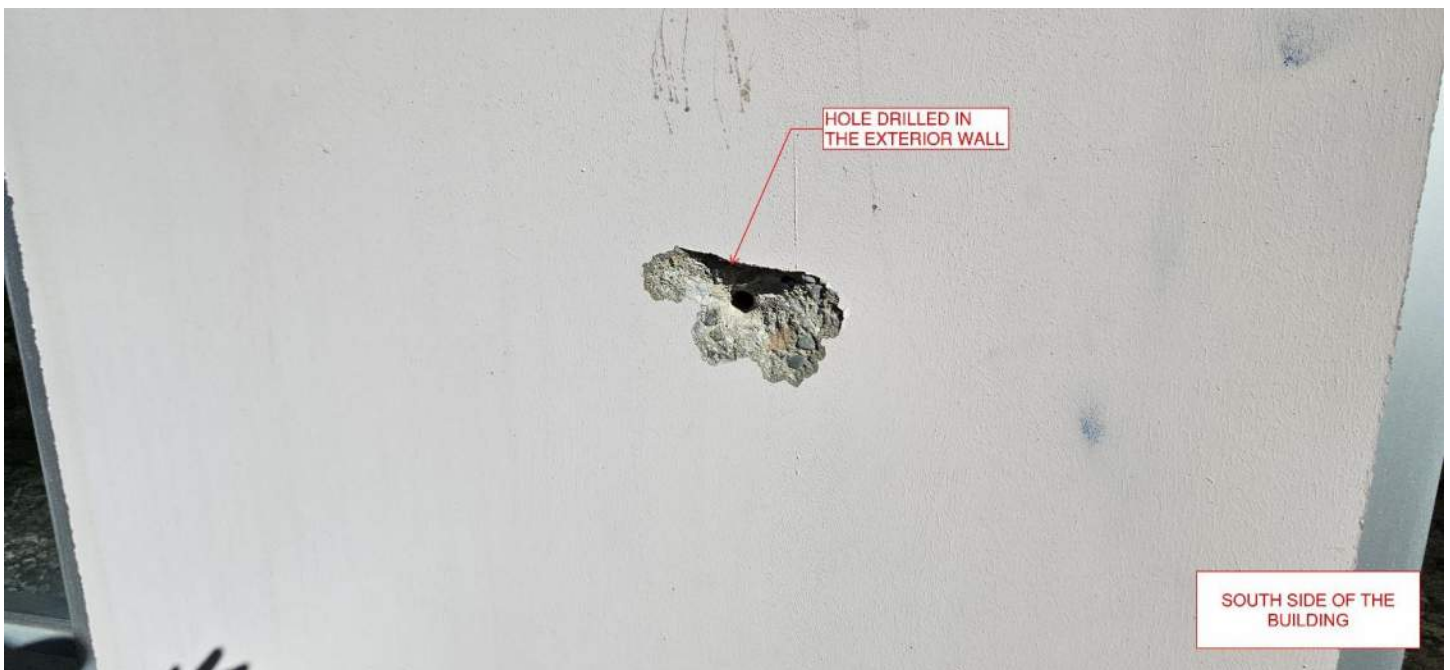
**FIGURE 21 - WALL PENETRATION AT IN THE SOUTH WALL**

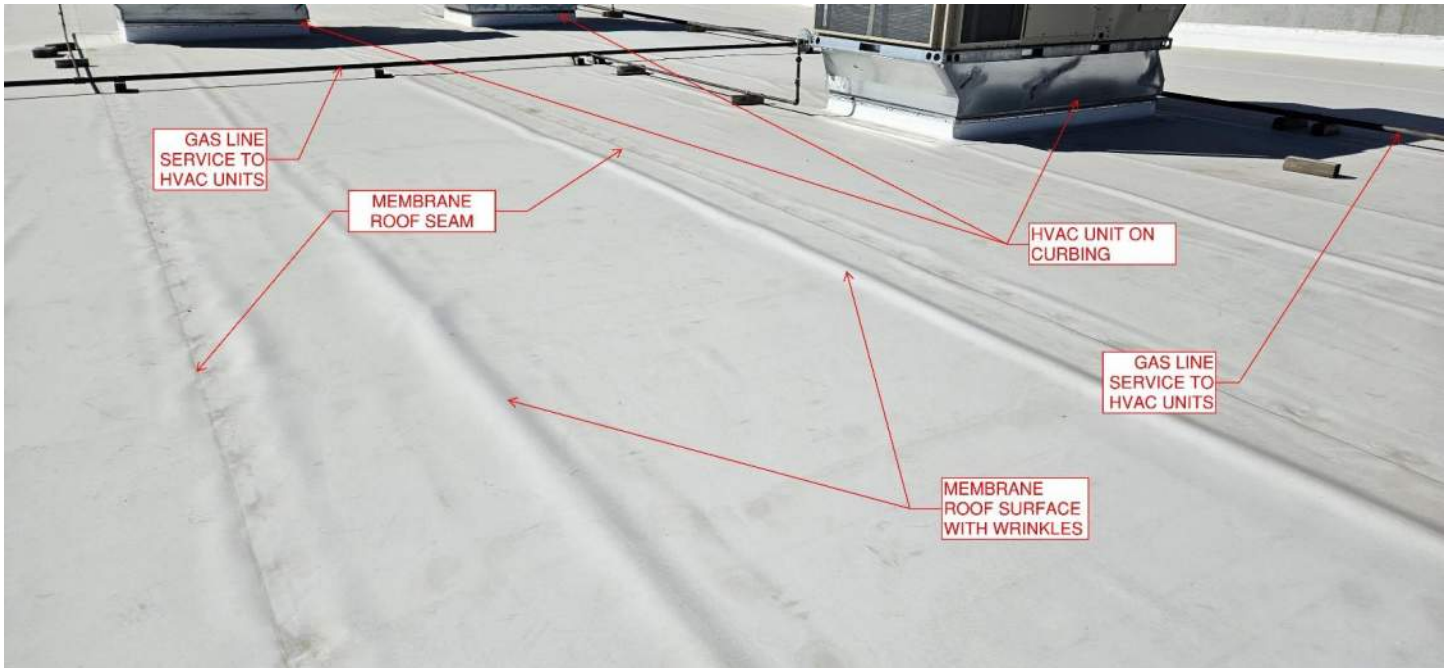
**FIGURE 26 - MEMBRANE ROOF**

3. The roofing membrane is in good condition, with only minor water ponding areas. The seams appear sealed and flashing around mechanical unit curbs and vents, are in good condition. The roof drains remove the water as needed; see Figures 26 through 30.

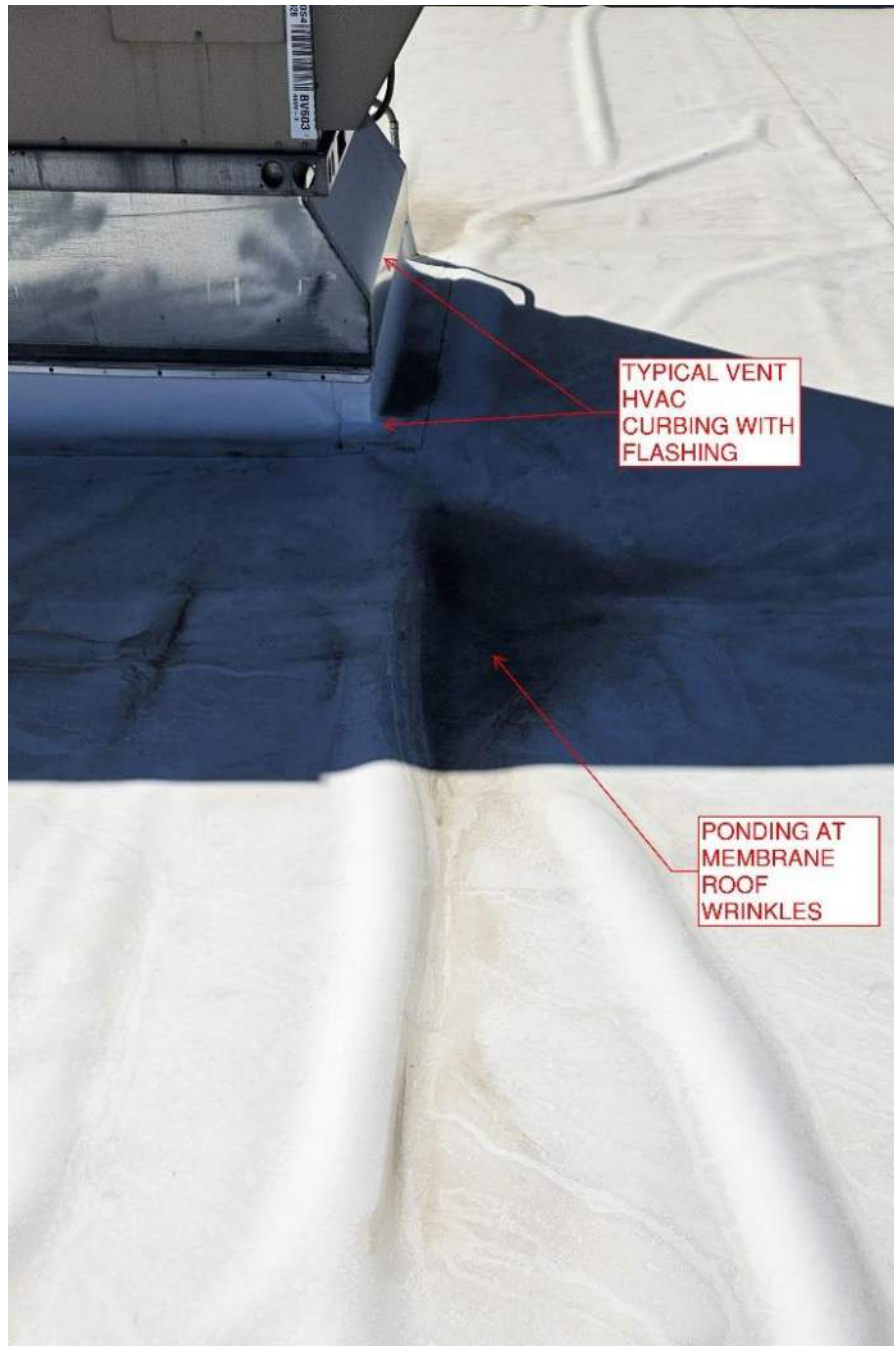
**FIGURE 30 - MINOR PONDING ON THE MEMBRANE ROOF**

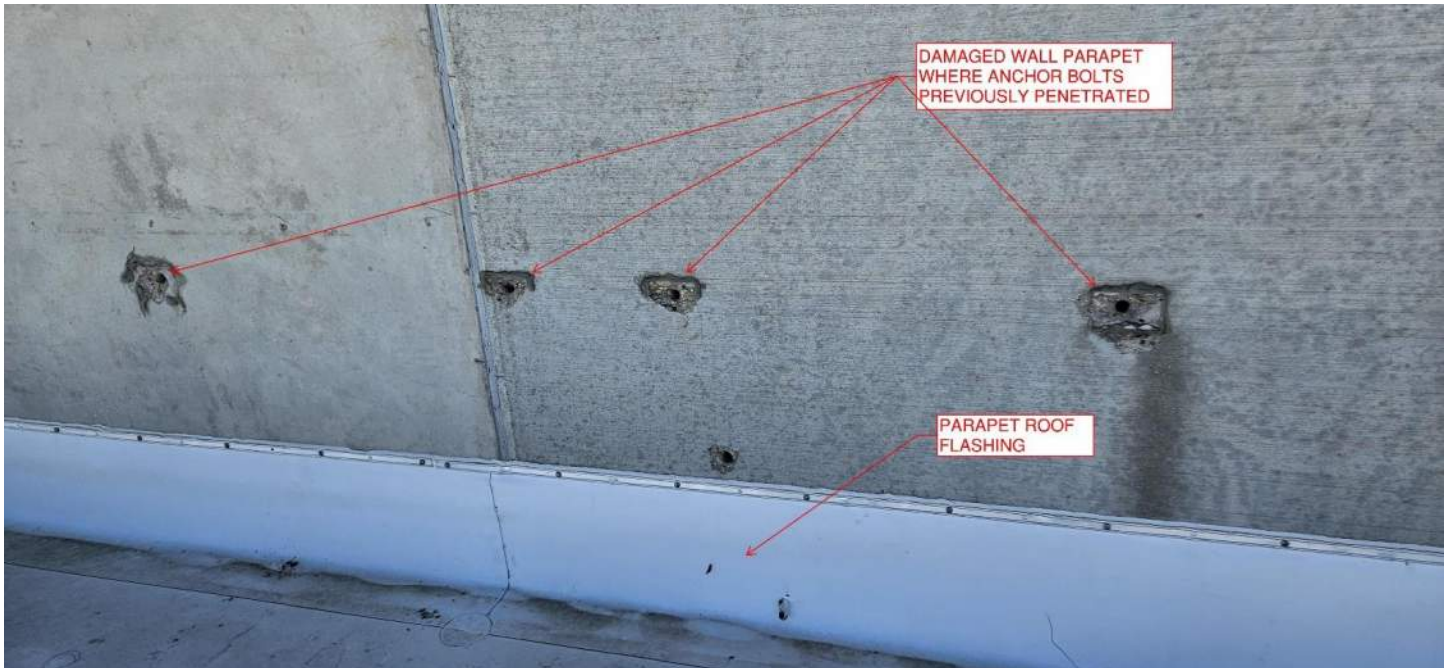
**FIGURE 31 - WALL PENETRATIONS AT THE EAST PARAPET**

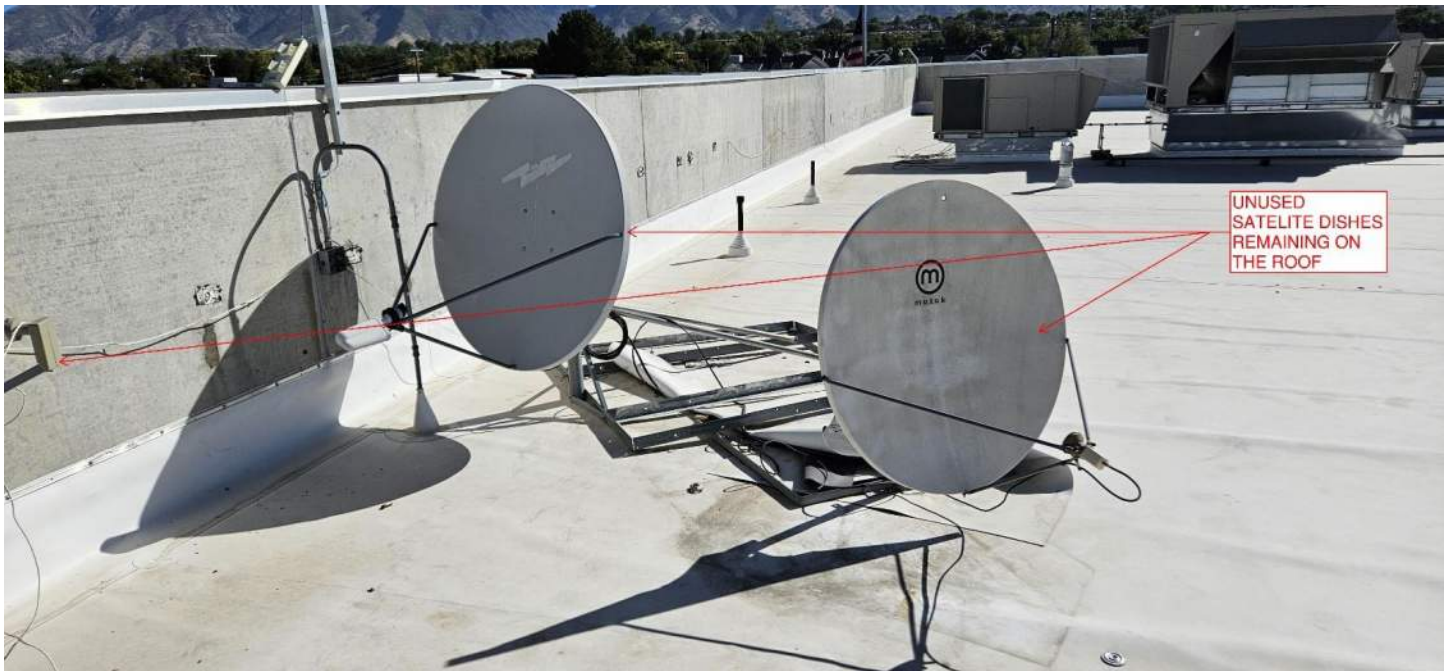
**FIGURE 33 - UNUSED SATELLITE DISHES**

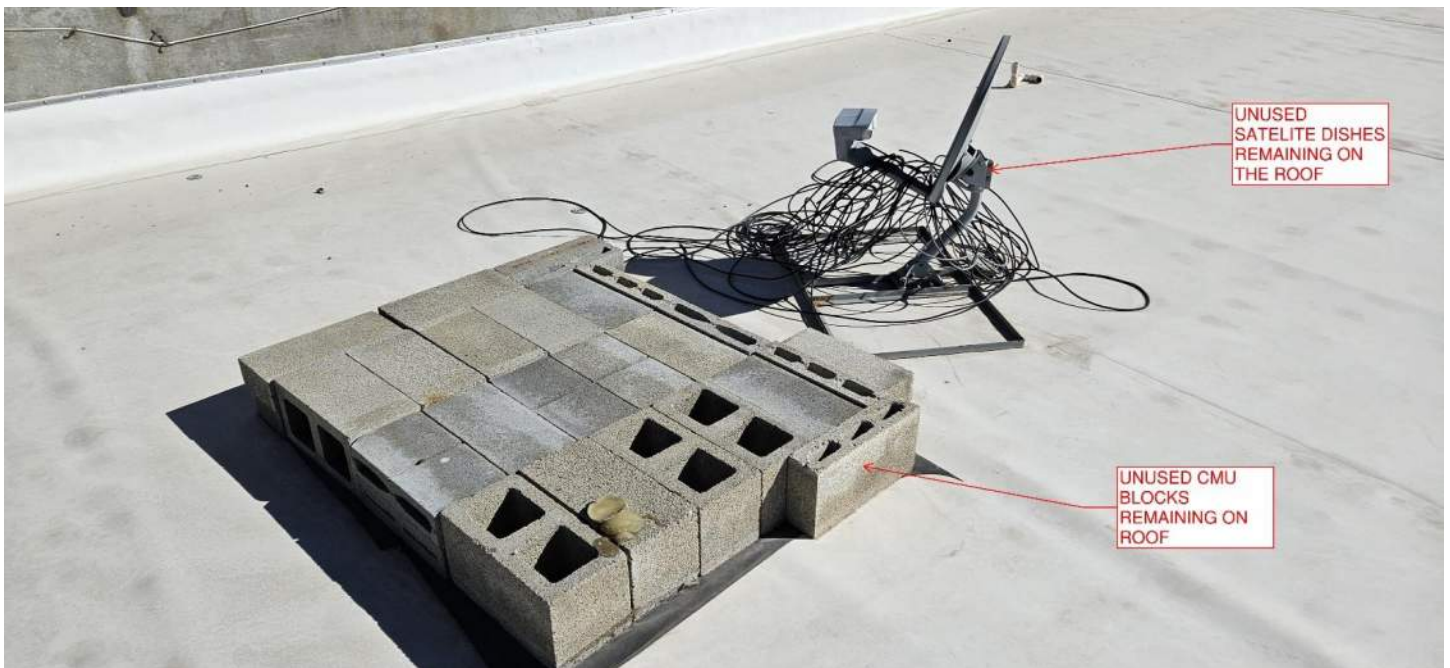
**FIGURE 34 - UNUSED SATELLITE CMU PLATFORM AND DISH**

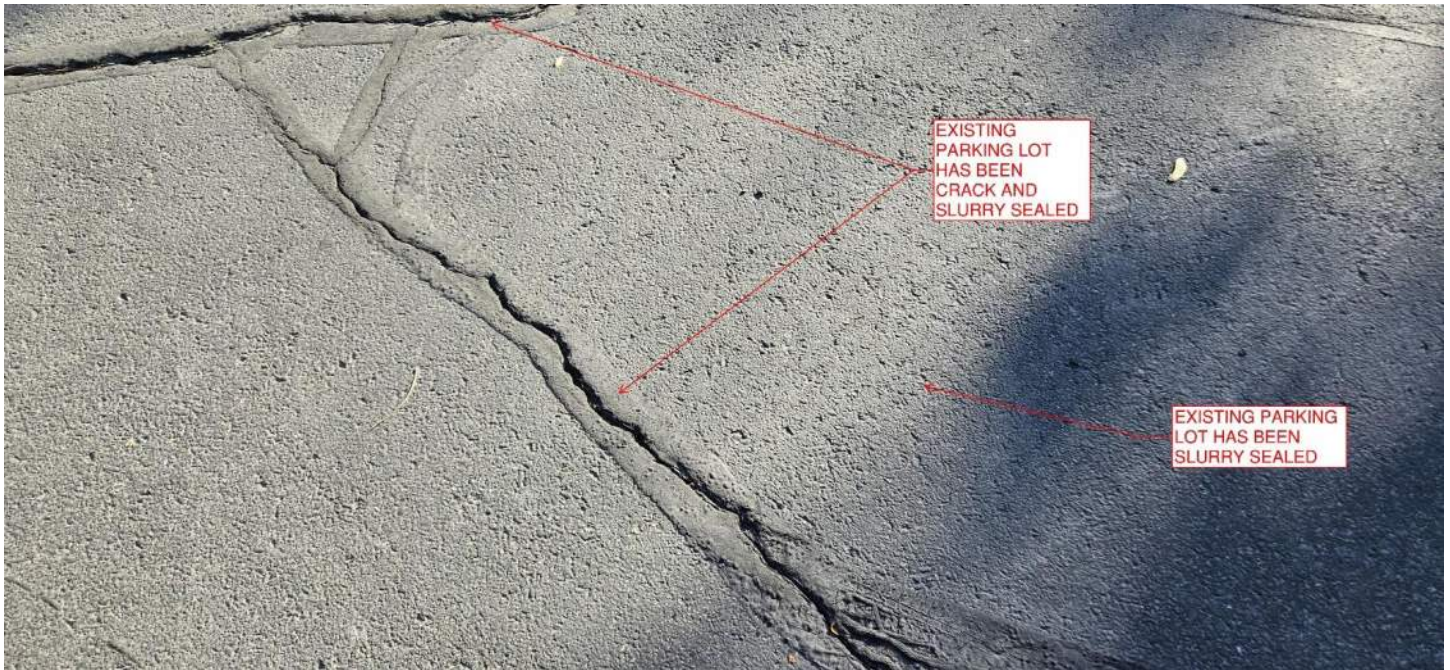
**FIGURE 35 - EXISTING PARKING LOT CONDITION**

11. The parking lot shows extensive cracking that has been addressed using a crack sealing material, and a slurry seal-type coating has been applied in the past. The sidewalks, curbs, and approaches on the premises are in good working order, as are those around the property's perimeter, see Figures 1 & 35.
