Re: 3381/3387 E 9980 South

We are requesting a variance on 2 items:

Geotechnical Opinion Regarding Disposition of the CIP Retaining Wall

Schneider Residence 3387 East 9980 South

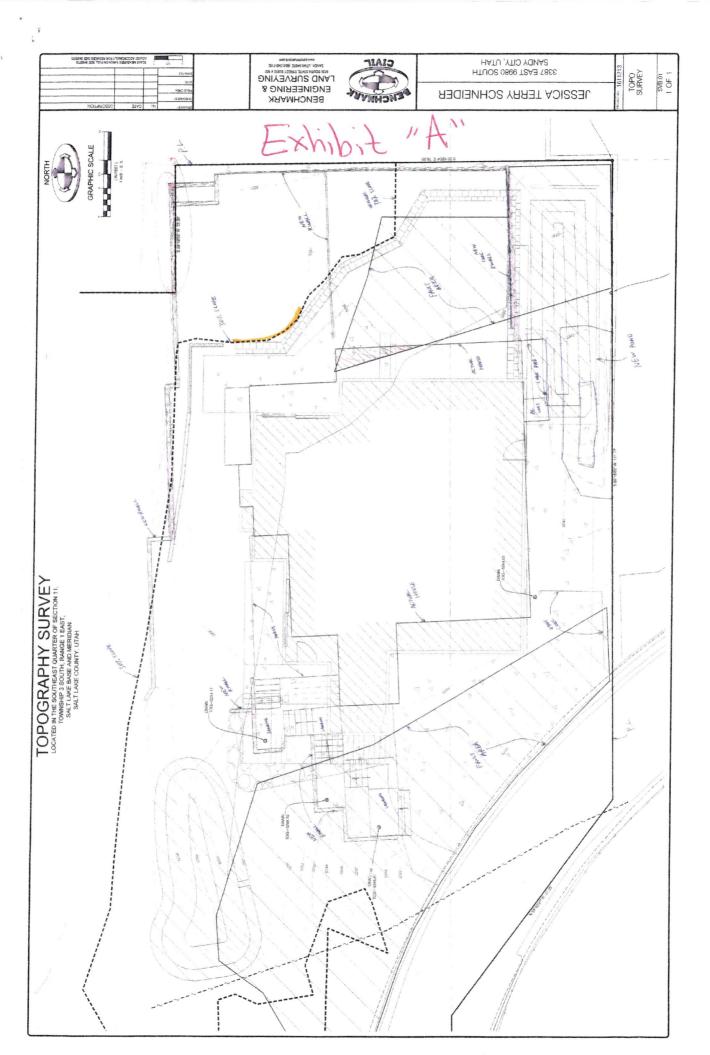
Exhibit A

1. **Foundation Placement/ 30% Slope Setback:** We solely relied on our builder during the foundation process and up to 4-way. Once the home was fully completed we were told the home was slightly tilted and poured/set in the wrong place. Given the extremely tight building pad this has put a small portion of our home at 7'.5", 8, 9' vs. 10' into the 30% setback area. We are requesting a variance on this item.

See Exhibit "A" (Final Survey from Benchmark)

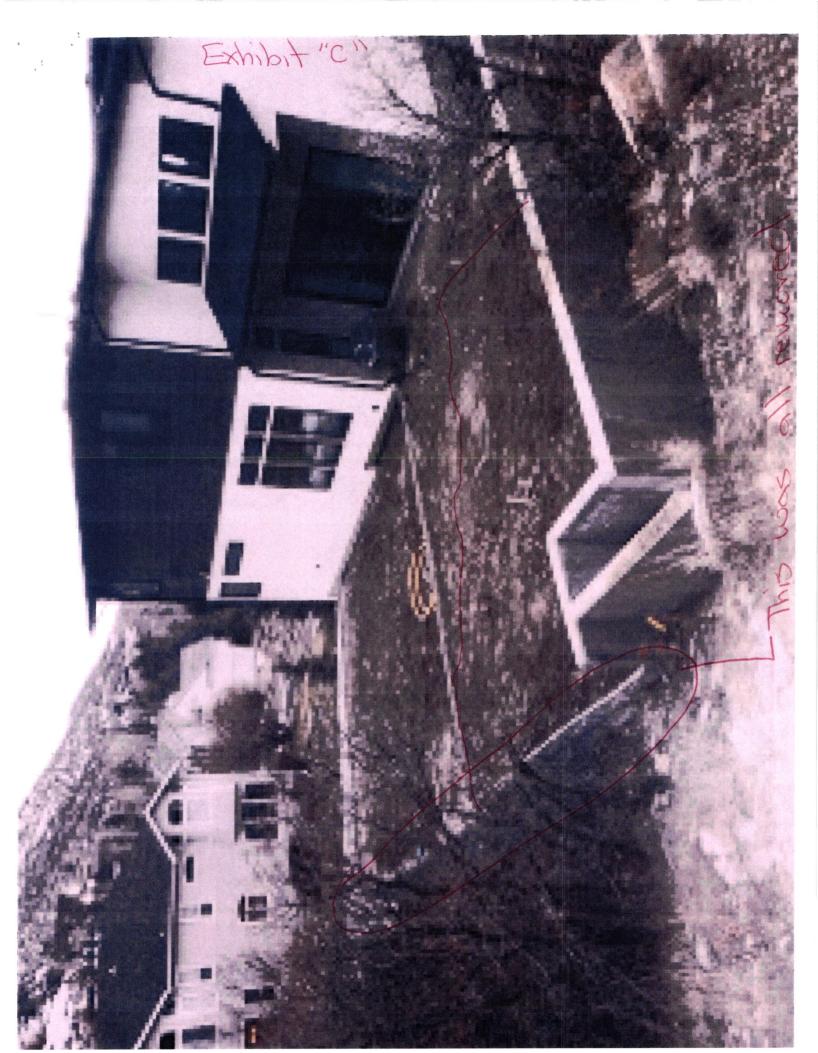
Retaining Wall Photos Figure 1

Photos Taken on April 26 and May 15, 2019

Schneider Residence Lock+Load Retaining Wall 3387 East 9980 South Sandy, Utah

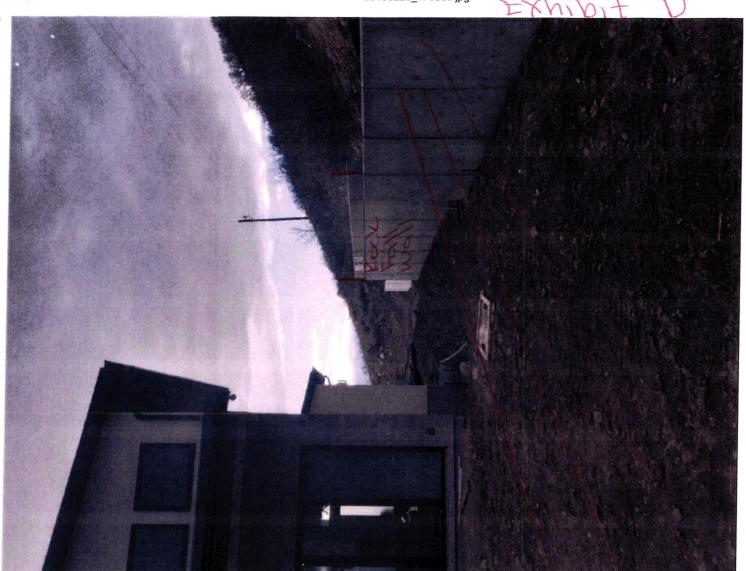
Schneider Residence 3387 East 9980 South Sandy, Utah East Retaining Wall Observation Photos Figure 1

The slope above the eastern wall extension does present a rockfall hazard (similar to the rest of the slope, where partially exposed boulders are present). Leaving the wall in

place will serve to reduce the risk of rockfall negatively impacting improvements over the design life of the home. It should be noted that part of this wall, as originally designed, was intended to mitigate the rockfall hazard inherent to the northern slope.

- The wall, as constructed, will also help mitigate erosion of the slope in this area, at least until natural vegetation can be re-established to pre-development levels, which may take several years.
- The presence of the concrete wall will have the added beneficial impact of helping to stabilize the toe of the slope, thus reducing the risk of localized surficial slope failure.

With respect to removing the existing as-built wall, it is the professional opinion of IGES that the City should grand a variance and the extended wall should be allowed to remain. Our opinion is based on the following:

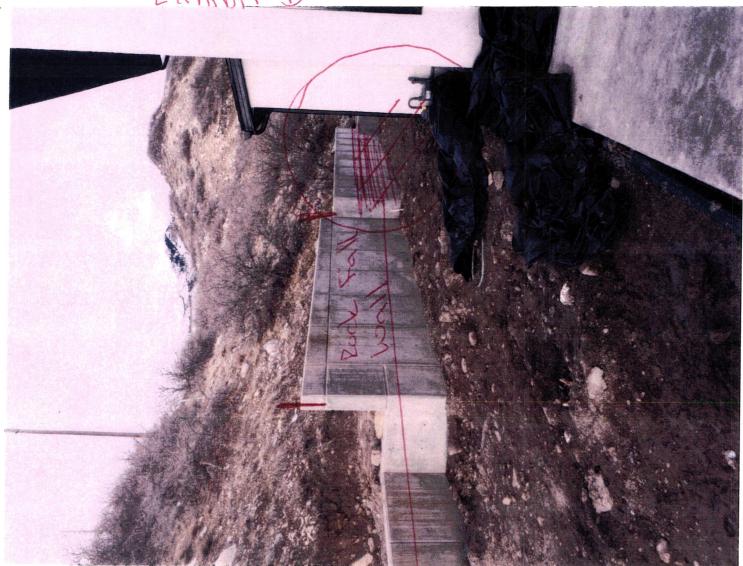
The dirt/30% slope tuns through the concrete wall.

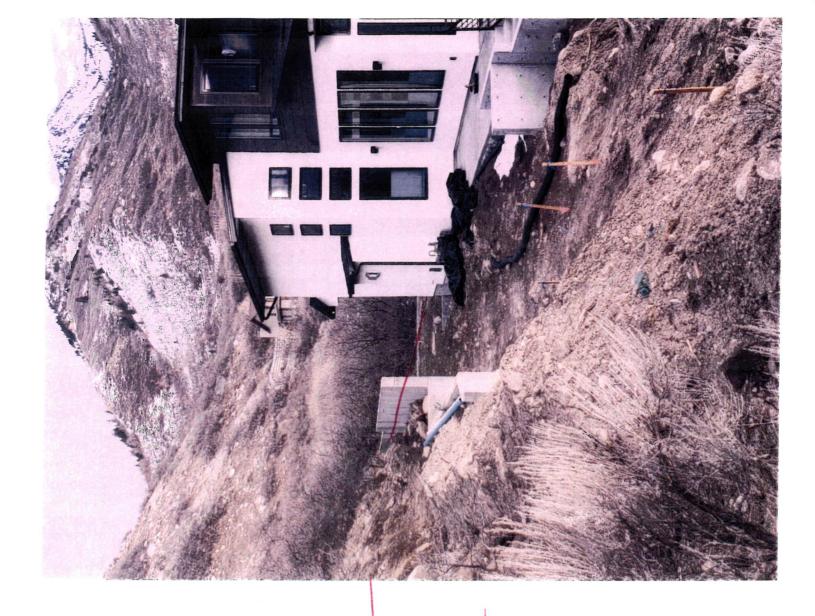
30% Slope/ Dirt runs Hurough Hue concret
