May 1, 2019

IGES Project No. 02441-005

Subject: CIP Concrete Retaining Wall Evaluation
Schneider Residence
3387 East 9980 South
Sandy, Utah

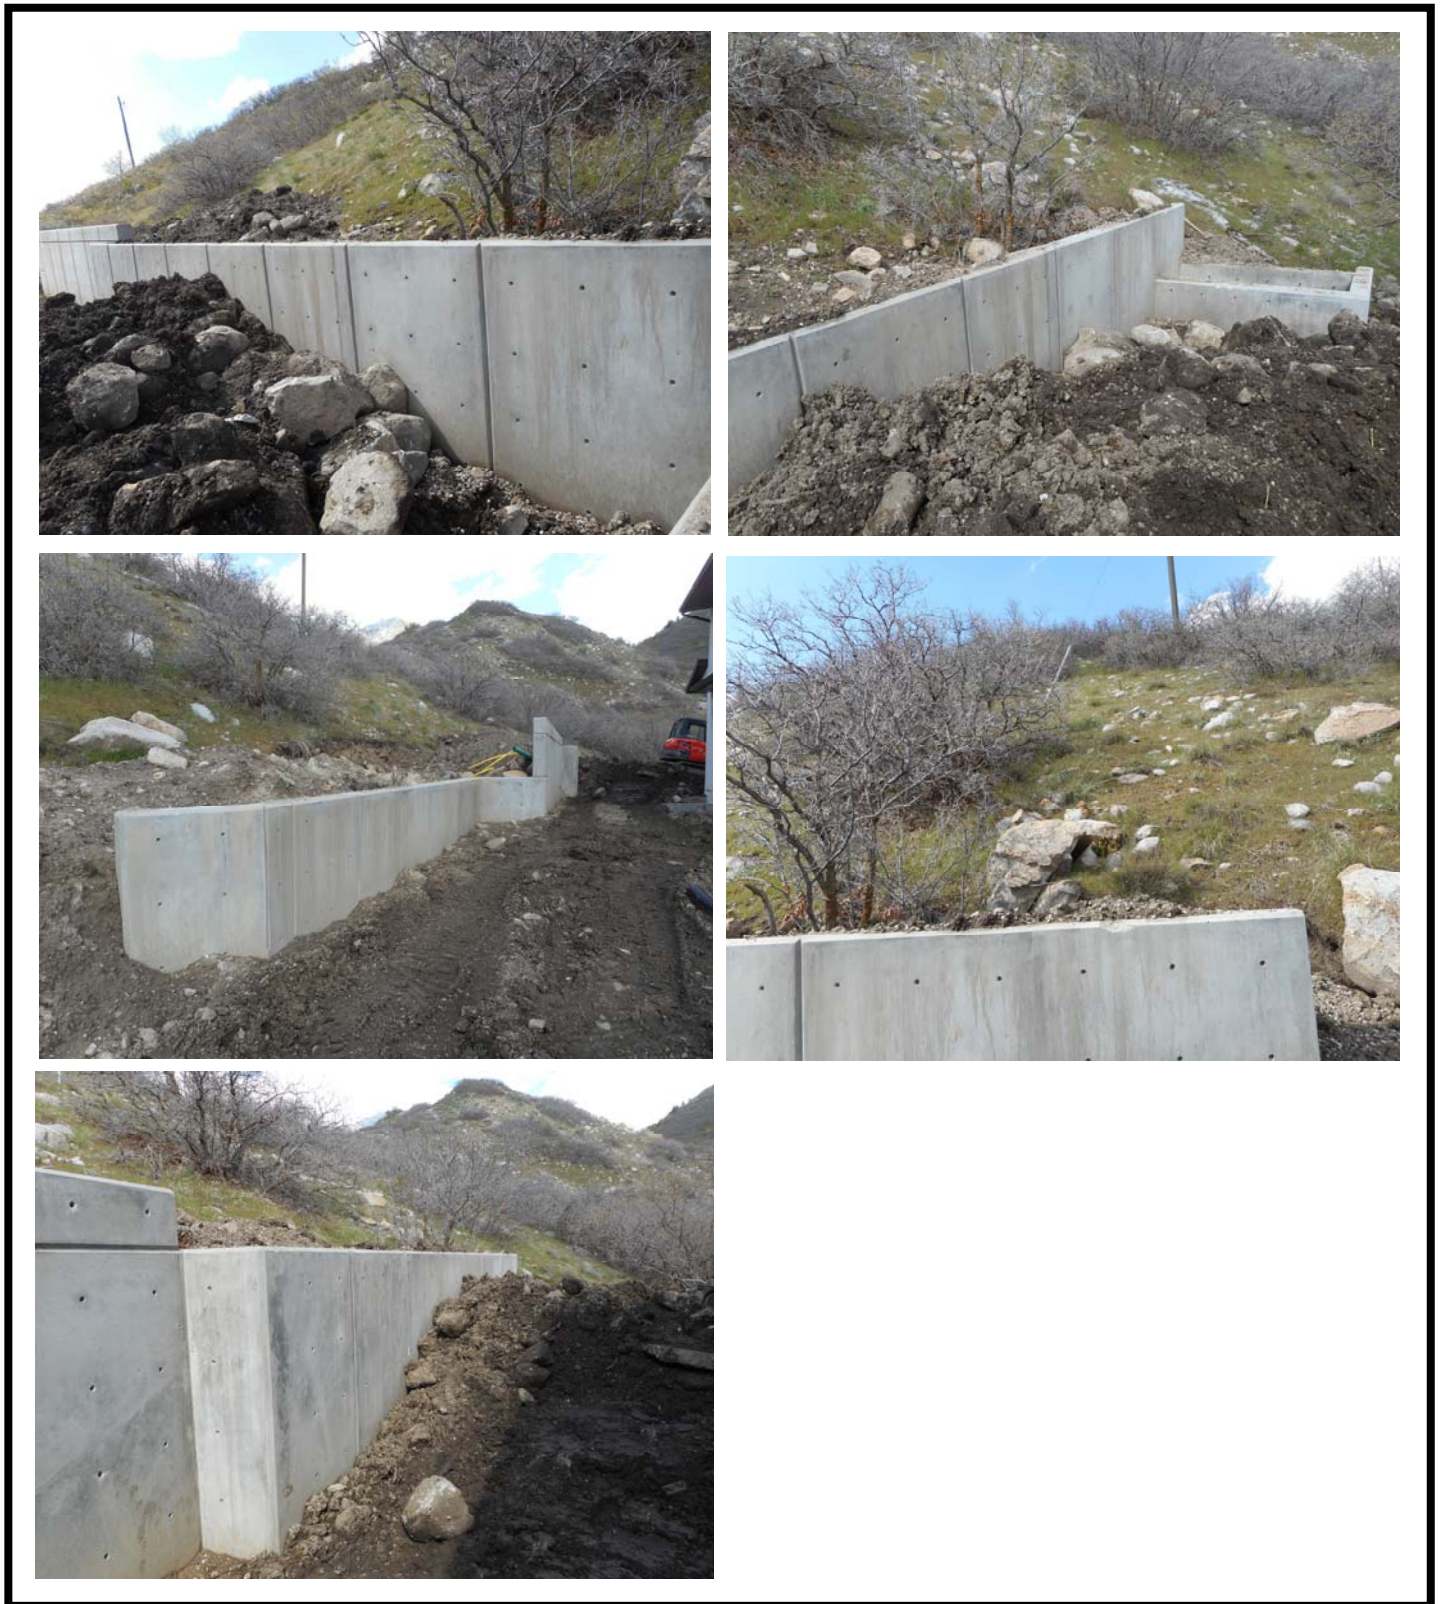
**Figure
1**

On May 1, 2019, IGES conducted a site visit to evaluate the completed wall. By observation, the wall appeared to be relatively straight and plumb. The wall does extend further to the east than originally designed, however this does not negatively impact the over-all performance of the wall. IGES did note that there was several feet of soil and rock stockpiled behind the rockfall barrier portion of the wall, just behind the home; we understand that this is a temporary condition, as the earth materials are being stockpiled there temporarily while the Lock-+Load MSE wall is being adjusted and the landscaping is being completed (Jessica Schneider, personal communication). No wall distress was observed.

Photos Taken on May 1, 2019

The soil stockpiled behind the wall should be removed as soon as feasible, as the wall is not designed for a full-height 6-foot retainage, and the stockpiled soil also compromises the ability of the wall to mitigate against rockfall (a clear distance of four feet is recommended). Temporary stockpiling is acceptable for a period of short duration to facilitate completion of the backyard improvements (about four weeks or less).

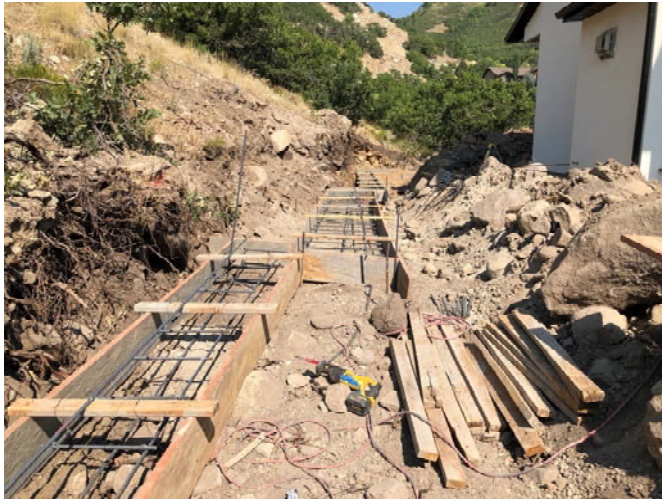
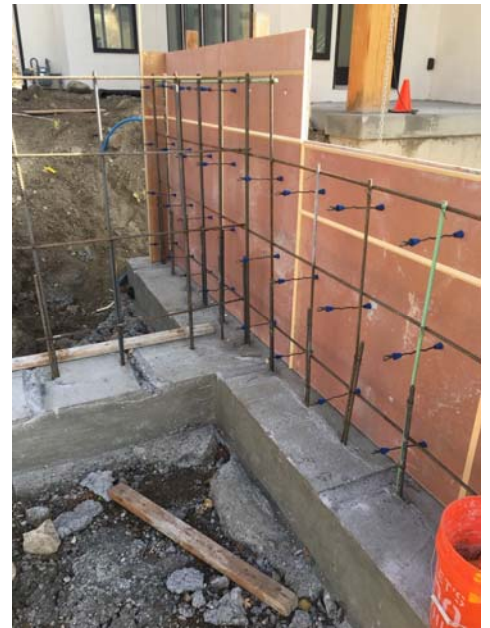
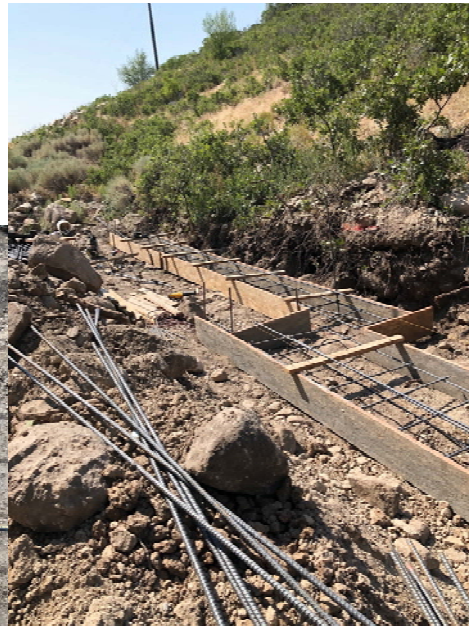
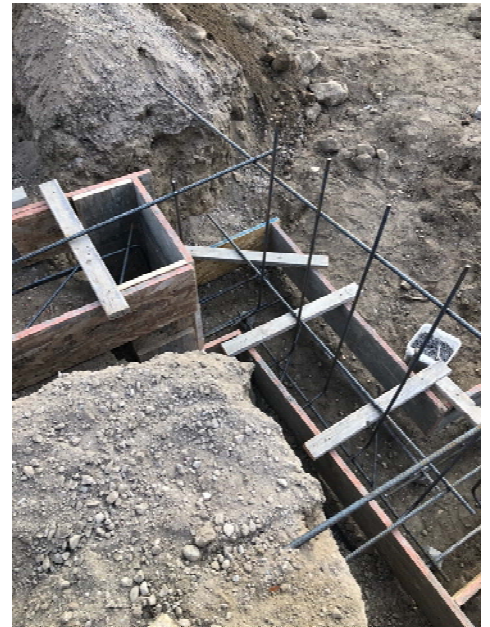
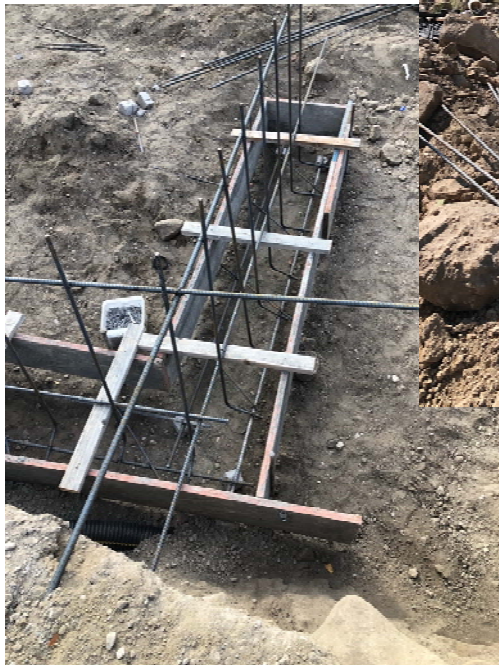
**Figure
2**

IGES did not directly observe the wall during construction; information regarding construction is based on information provided by the Contractor (Limitless Construction, Mr. Jake Myler), and photos of the construction provided by same. Based upon a qualitative review of the provided photos, the rebar used in the construction appears to be of the correct size and has been tied in the correct positions and spaced appropriately (although direct measurements could not be made). The wall's foundation subgrade was not observed directly; however, based on the photos, and considering the wall was constructed a few feet into a natural slope, it is likely that the wall foundations were founded on relatively undisturbed native subgrade.

Photos Provided by Limitless Construction
