Sandy City – Old City Hall Study Update

Date: December 6, 2017
To: Todd Asay
From: CRSA – Susie Petheram, Kelly Gillman
Re: Summary of site visit, code analysis, cost considerations

Sandy City Old City Hall Study

June 2008

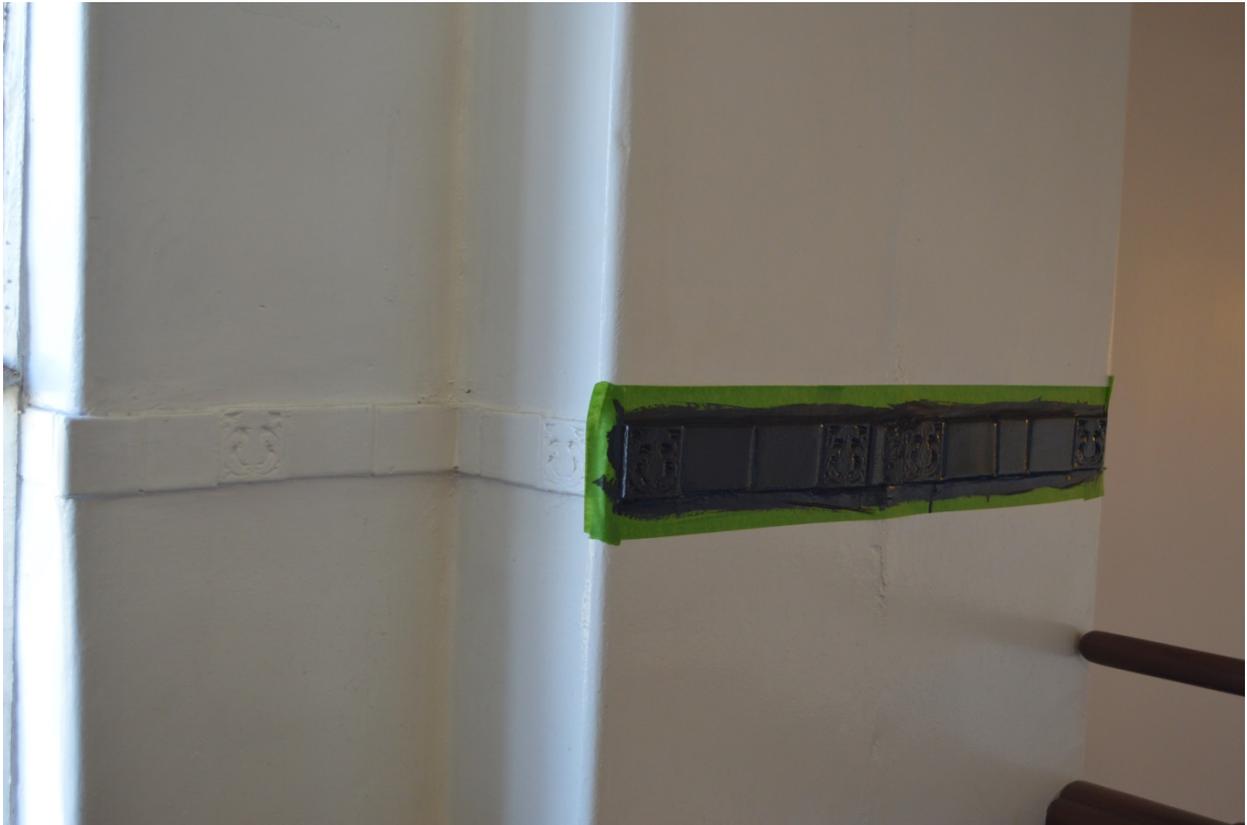
Image 1: Updates to the building include aesthetic improvements, such as detail painting of the decorative accent tiles in the hallways.

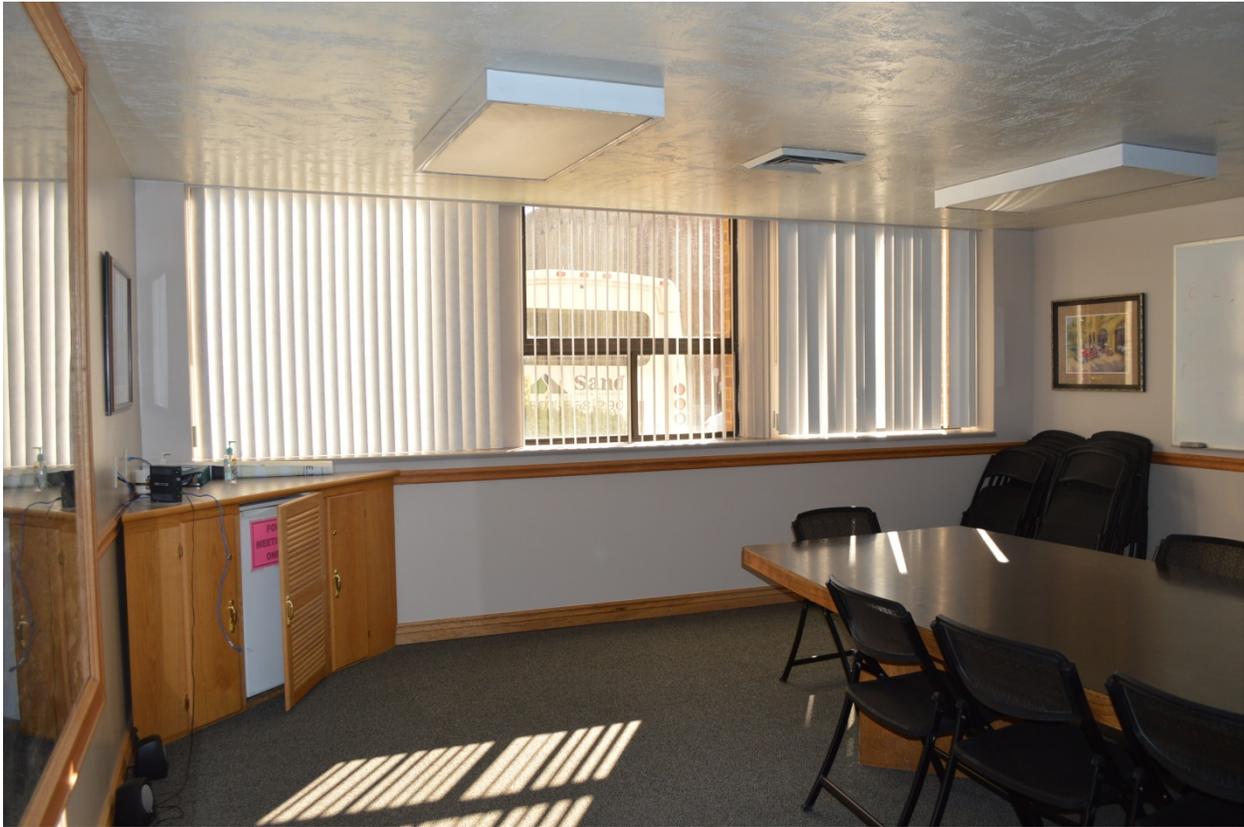
Image 2: The main level conference room is rented out for community use.

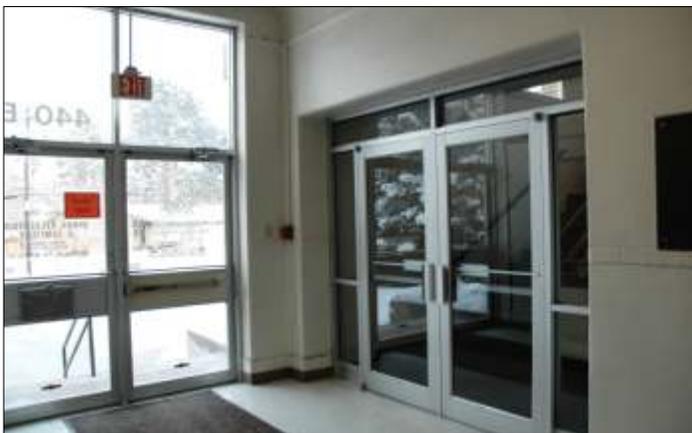
Aluminum storefront doors have replaced the historic wood panel doors at all three of the main entrances.

appearance. Modern steel windows are available with thermally-glazed inserts that would perform to modern energy conservation standards. Exterior muntins can be applied to the windows to match the configuration of the historic divided-light windows. Aluminum storefront entrance systems could be configured such that the doors themselves mimic the appearance of the original doors, as seen in the original construction drawings.

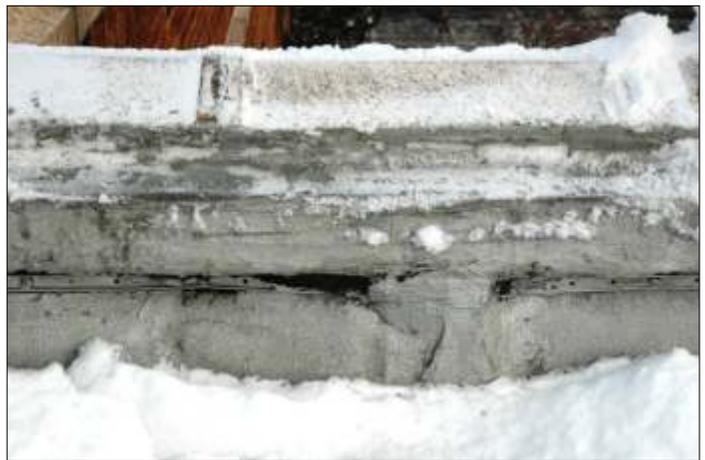
Flashings at penetrations such as plumbing vents consist of some old sheet metal, with roofing membranes extending up the parapets and terminating just below the coping at the perimeter parapets. Terra cotta tiles are in fair condition, but mortar has significantly deteriorated. The perimeter terra cotta coping is addressed above.)

Roofing membranes currently extend up the parapets to terminate just below the coping.

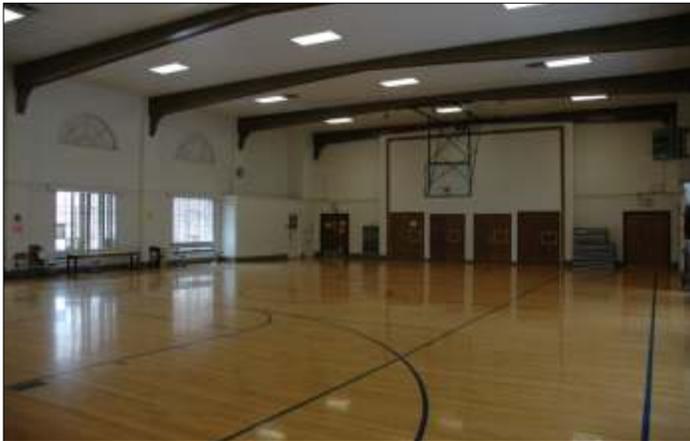
The gymnasium remains, although the stage area (far end of photo) has been filled in with storage and meeting rooms. The maple floor is thought to be the original.

flooring in these areas is intact. The maple flooring in the gymnasium may be the original flooring as numerous repairs are visible. However, it also appears that the flooring may not sustain another refinishing, which usually involves completely re-sanding the surface.

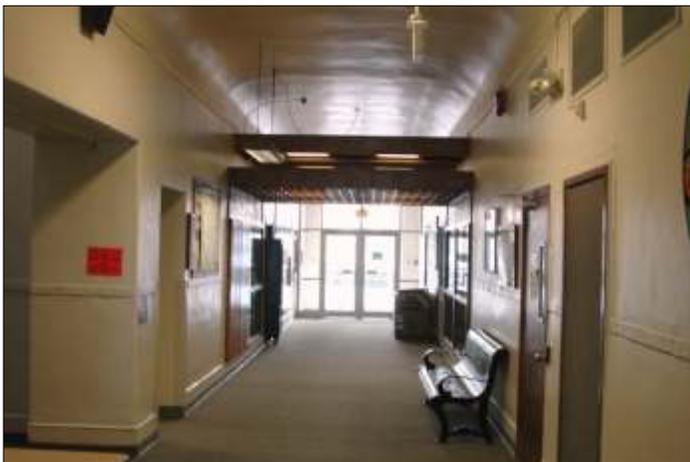
The central corridor on Level 2 retains its original high coved ceiling. With the exception of the gymnasium the remainder of the corridors and rooms have dropped ceilings in place.

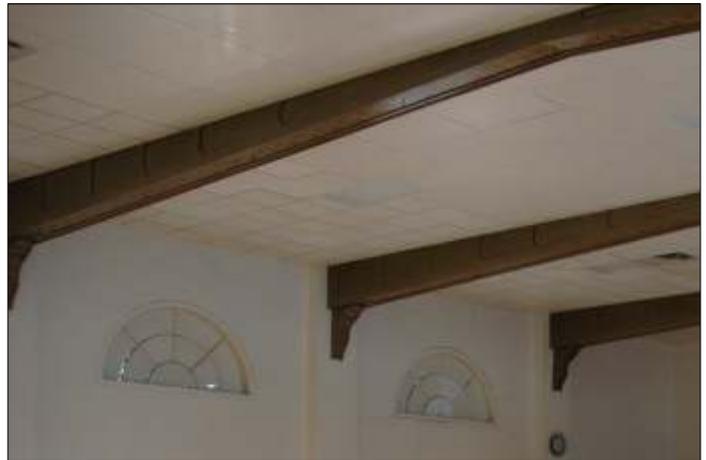
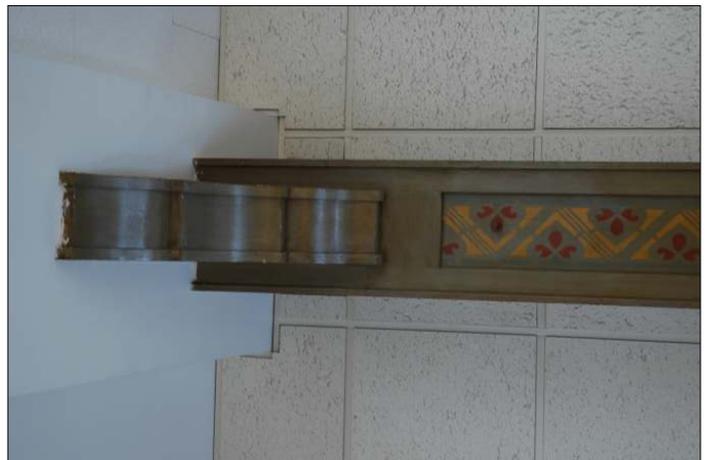
Most original plaster ceilings are now hidden by modern acoustic lay-in panel ceiling systems. Later mechanical ducts have also been installed in the interstitial space between the original and newer ceilings. The gymnasium ceiling has not been lowered, but the ceiling has been re-covered with acoustic tiles in various styles and sizes.

Decoratively painted soffits are below each bow truss of the gymnasium ceiling.

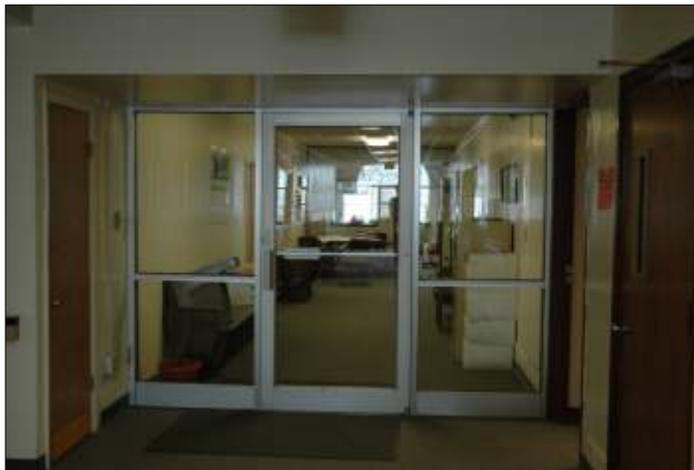
Modern wood slab doors have replaced the original wood panel doors throughout the building. Additional aluminum frame storefront doors have been added to cordon off the south end of the Level 4 corridor.

Glazed paneled wood doors may be found similar to the original doors for an office use, but would be inappropriate for residential use due to the required fire resistance rating. For any reuse scenario, paneled doors are preferred. Slab doors of any kind are discouraged. Similarly, if any interior windows are installed, wood-stopped systems are preferred to either steel or aluminum to imitate the original wood interior windows.

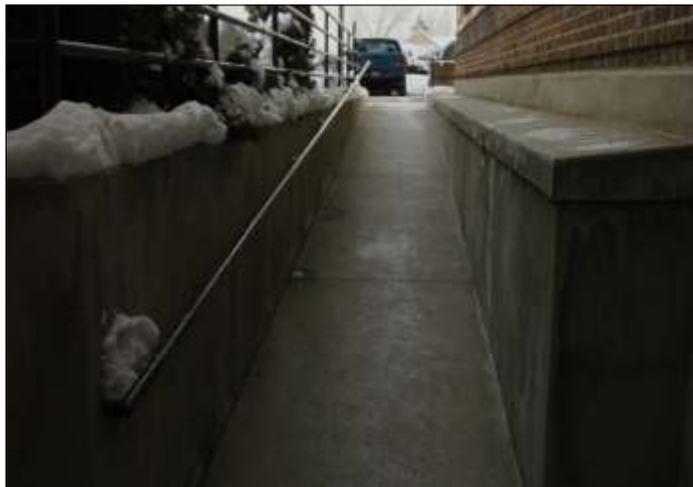
An existing ramp provides access to the first level.

easily be altered to be accessible. It is also possible to add restrooms to upper levels, where now only those on Level 1 exist. In short, it is recommended that all efforts be made to meet accessibility criteria to the maximum extent possible. The existing non-compliant ramp on the south side of the building will no longer be needed for access, but can remain as a service ramp.
