Property Report

9272 S 700 E, Sandy, UT 84070

Date: November 11, 2024

24046
REB

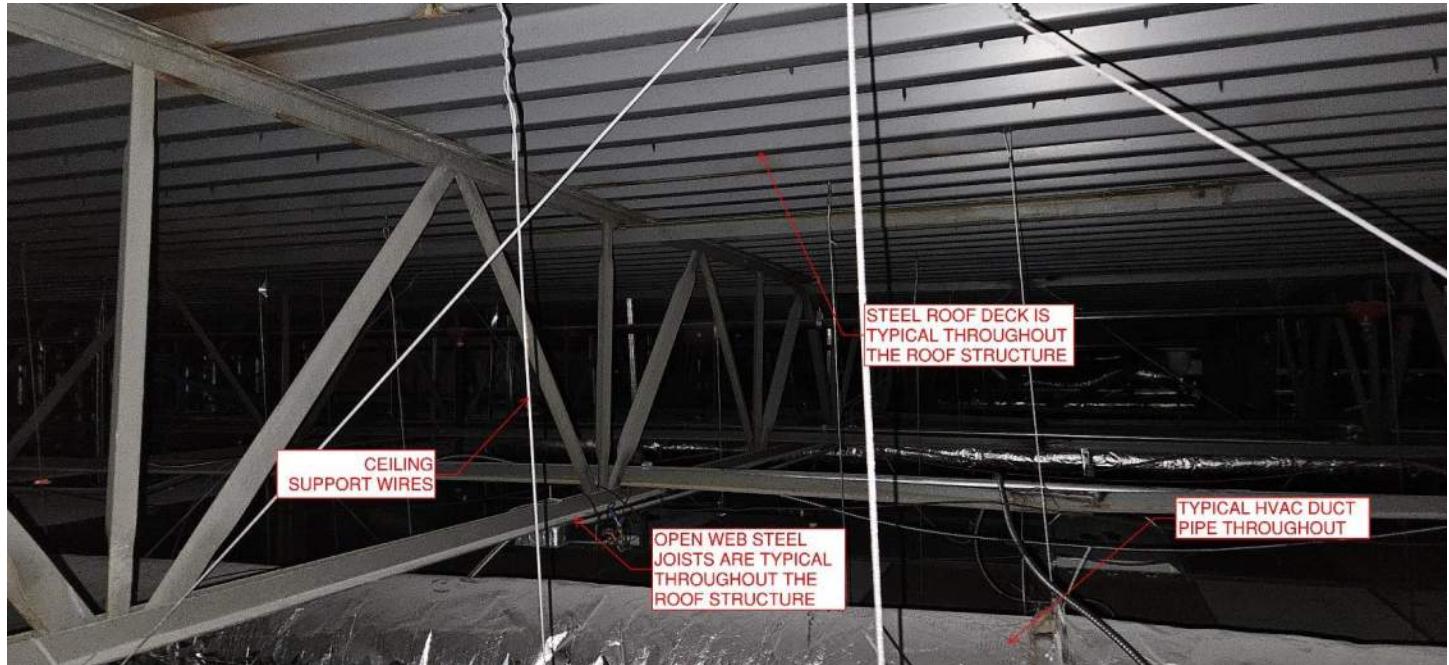
FIGURE 7 - ROOF FRAMING

1. The building was built in 2000, according to the [Salt Lake County Assessor](#).
2. The structural elements, which include the roof deck, open web roof trusses, open web floor trusses, and columns, are in good condition, as is expected for a building of this age. The foundation could not be observed as it is buried beneath the existing structure. However, the condition of the foundation system is not expected to be damaged or in need of repairs. See Figures 7 through 11.

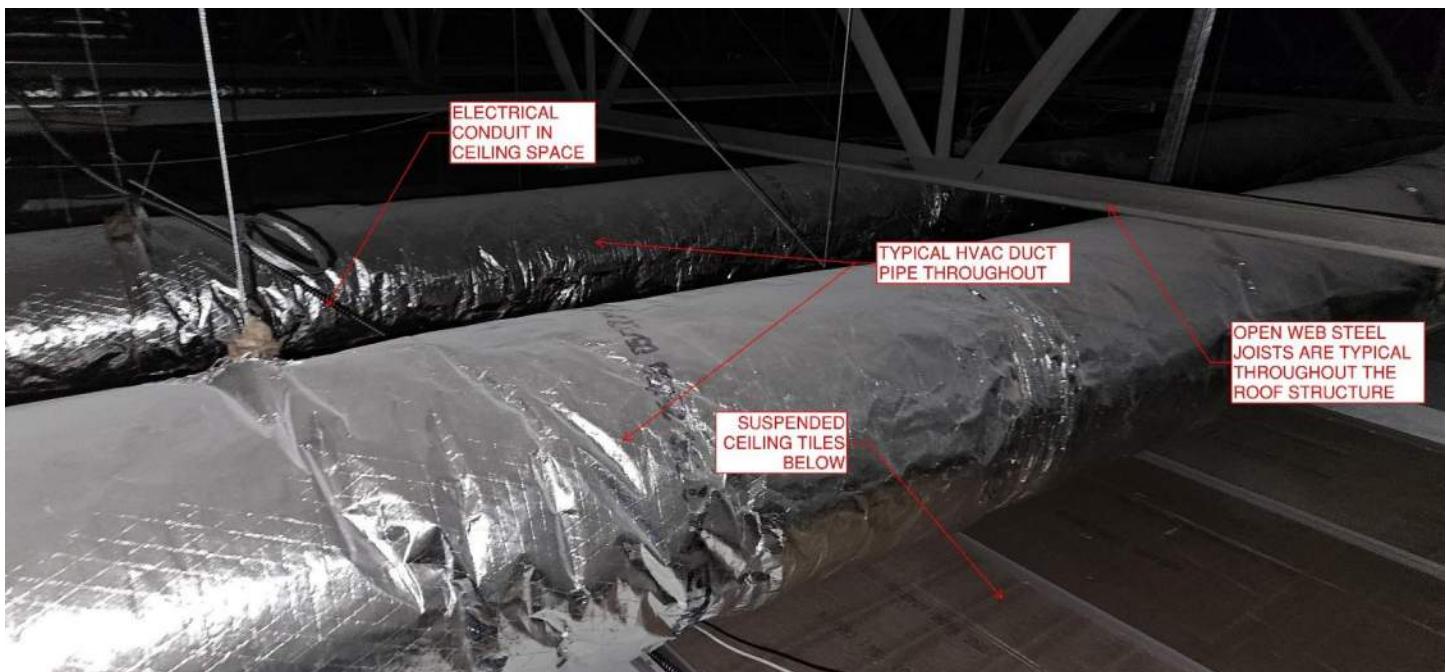
FIGURE 8 - UPPER FLOOR CEILING SPACE

4. Mechanical systems such as HVAC units and duct work appear to be in good condition from an exterior view. These units have gas lines running to each unit on the roof, so we assume the units provide both heating and cooling. We suggest an HVAC technician investigate the current status of all units and ductwork for conditions that need attention, as this is beyond the scope of our expertise; see Figures 8, 9, 11, 14, 17, 24, 25 & 28.

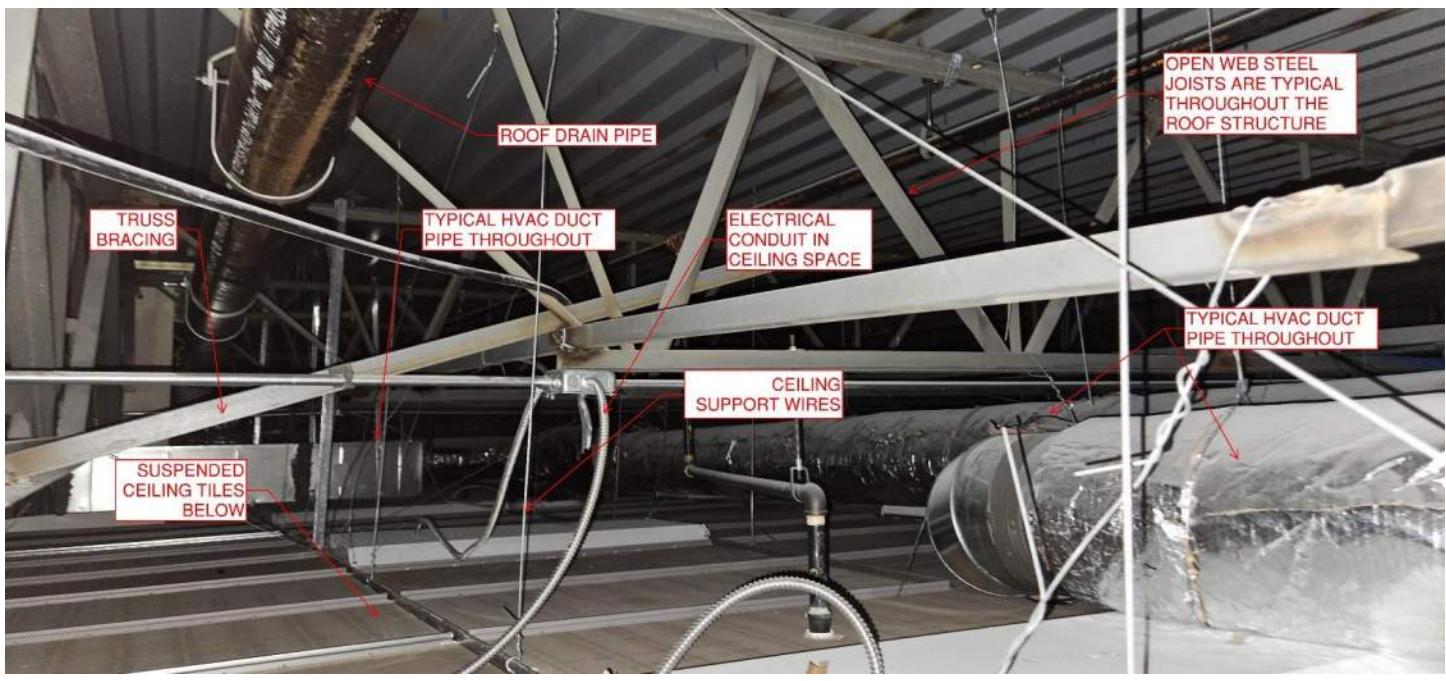
FIGURE 9 - UPPER FLOOR CEILING SPACE

conduits, switches, lights, power outlets and breaker boxes for conditions that need attention, as this is beyond the scope of our expertise. Our only observation that brings anything into question is the condition of the power transformer outside the building. It shows weathering and rust damage on the exterior; only the power supply company with access can determine the existing condition if any repairs or maintenance is needed; see Figures 9, 15, 16 & 23.

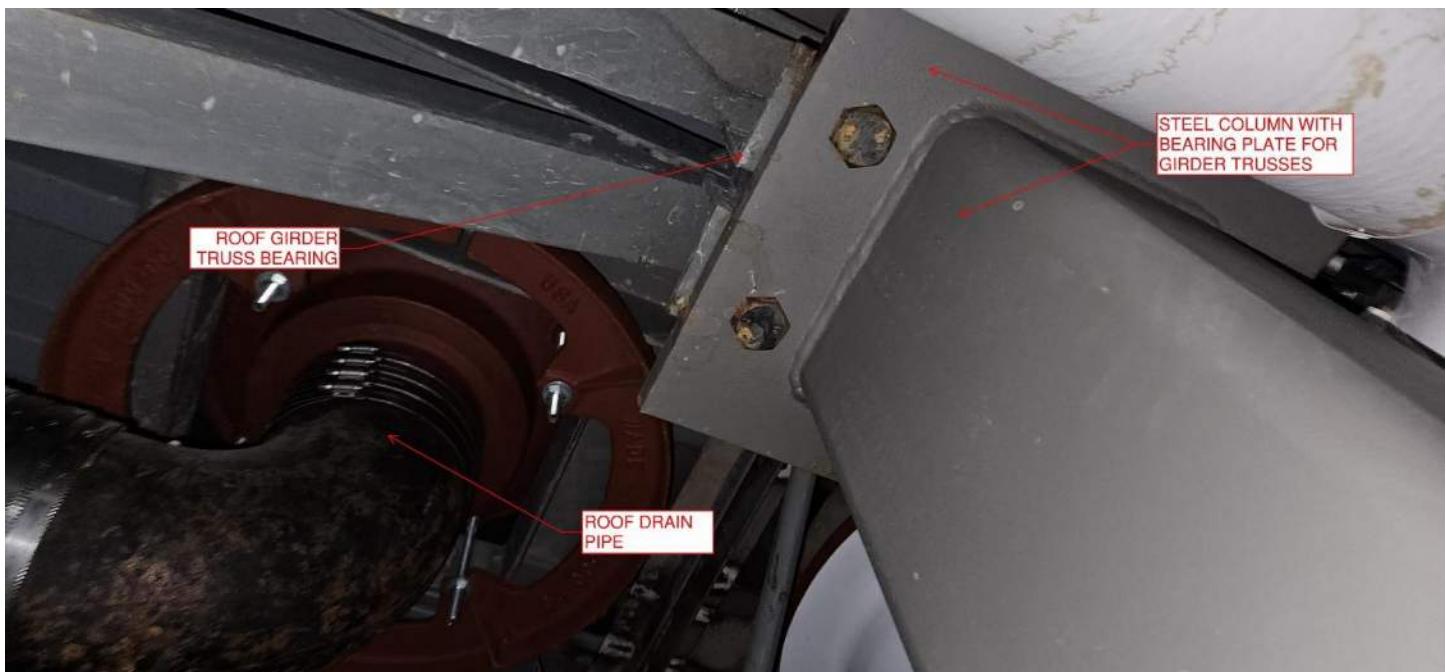
FIGURE 10 - GIRDER TO COLUMN CONNECTION

6. Plumbing systems, including roof drainage piping that could be viewed, appear to be in good condition from an exterior view. We could not find any excessive problems with water supply fixtures. The toilets and other drains are working as expected. We suggest a licensed plumber investigate the current status of all fixtures, toilets, and other water sources to be examined for leaks or conditions that need attention, as this is beyond the scope of our expertise; see Figures 10, 13, 15 & 27.

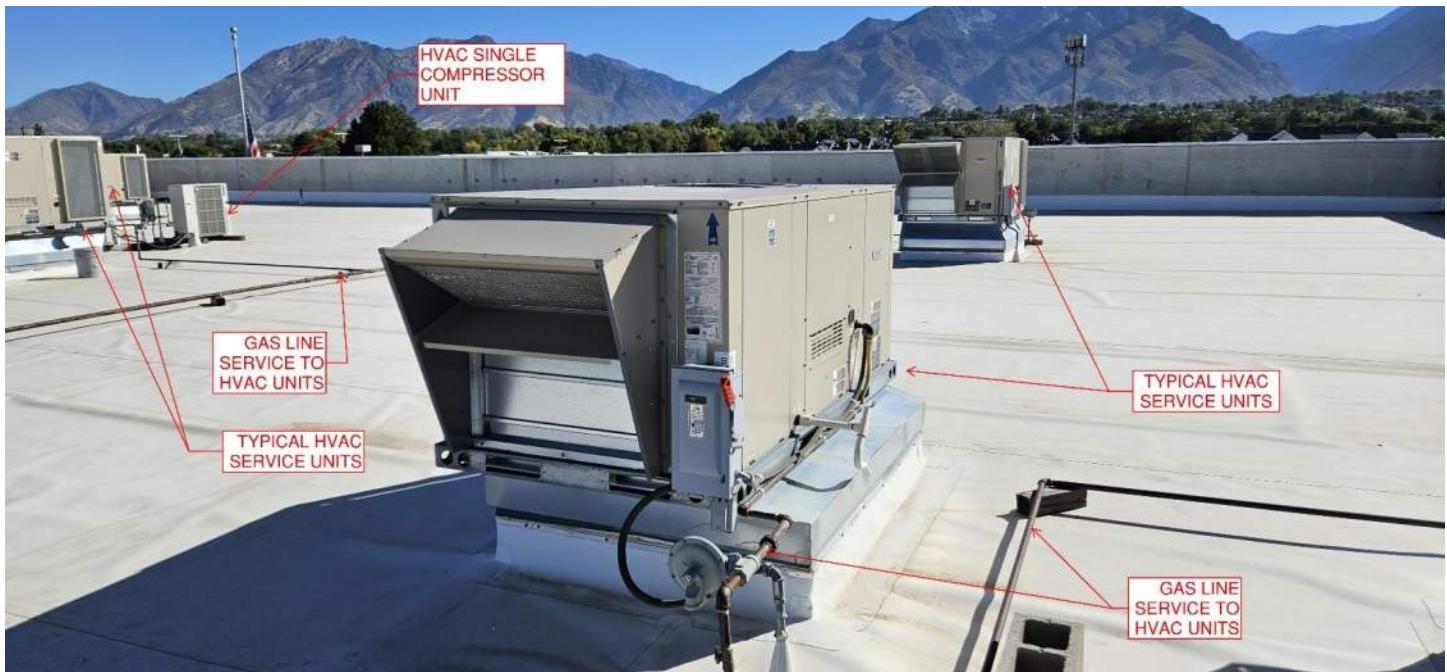
FIGURE 28 - MULTIPLE ROOFTOP HVAC UNITS

3. The roofing membrane is in good condition, with only minor water ponding areas. The seams appear sealed and flashing around mechanical unit curbs and vents, are in good condition. The roof drains remove the water as needed; see Figures 26 through 30.
