# **Property Report**

**Alta Commercial Development LLC  
Brooke Hintze**

9272 S 700 E, Sandy, UT 84070

Date: November 11, 2024

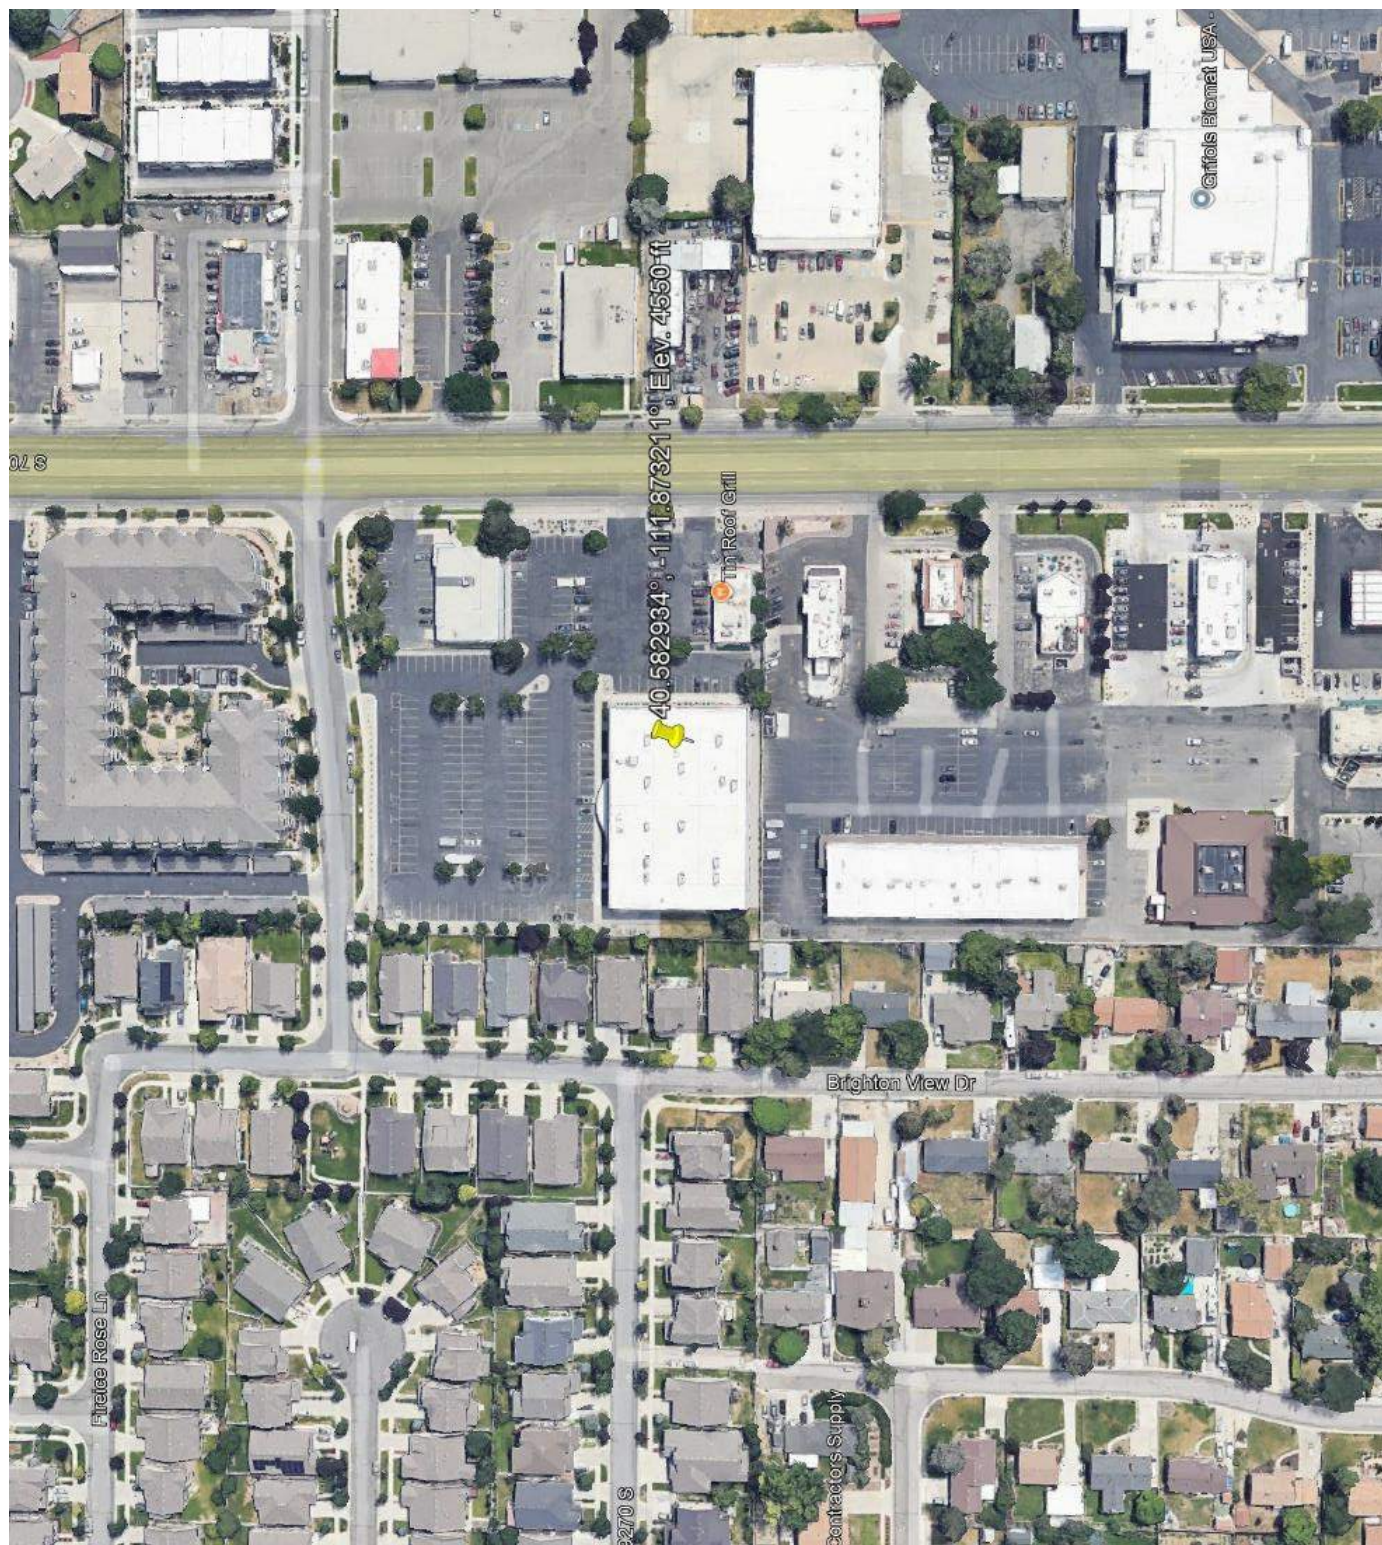
**FIGURE 1 - PROJECT LOCATION**

9. Water is supplied via a 2" diameter pipe. This information was obtained by Brooke Hintze on October 2, 2024, from Sandy City Public Utilities.
10. There are no private streets involved in this project. There is only direct access to the property from the north off of Rose Cottage Lane and from the East off of 700 East; see Figure 1.

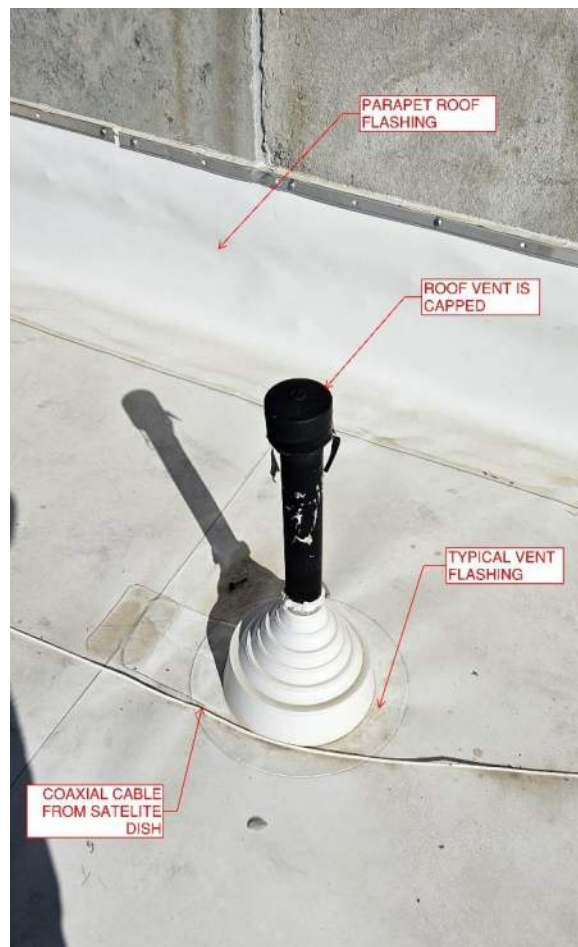
**FIGURE 32 - CAPPED ROOF VENT WITH TYPICAL FLASHING**

3. The roofing membrane is in good condition, with only minor water ponding areas. The seams appear sealed and flashing around mechanical unit curbs and vents, are in good condition. The roof drains remove the water as needed; see Figures 26 through 30.
